Environmental Monitoring Report

Semi-annual report
July – December 2021

Kyrgyz Republic: Toktogul Rehabilitation Phase 2 Project

Prepared by the Open Joint Stock Company Electric Power Plants, with the assistance of the Project Implementation Consultant Tractebel Engineering - Coyne Et Bellier (France) in association with Endustriel Elektrik Maden LLC (Kyrgyz Republic).

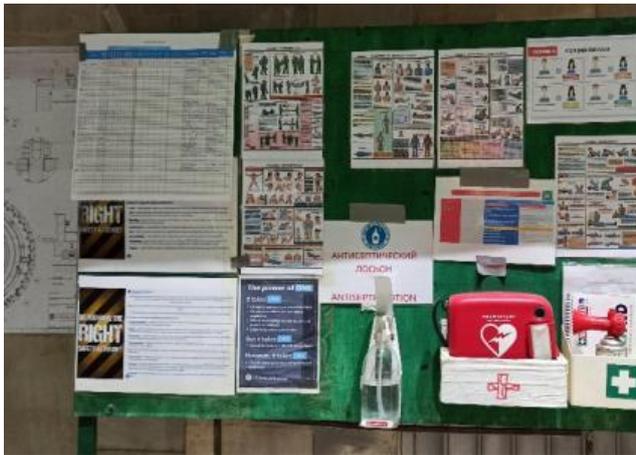
Figure 2. First-aid kit, antiseptic and informative board at work area of CC GE (Status in November 2021)

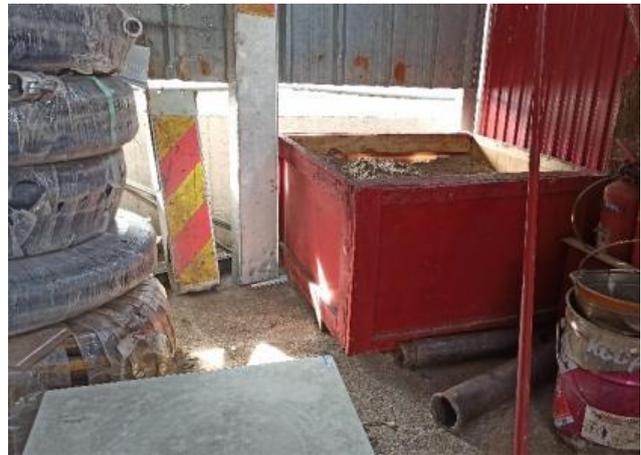
Figure 3. Fire extinguishers are available at work area of CC ZMEC (Status in November 2021)

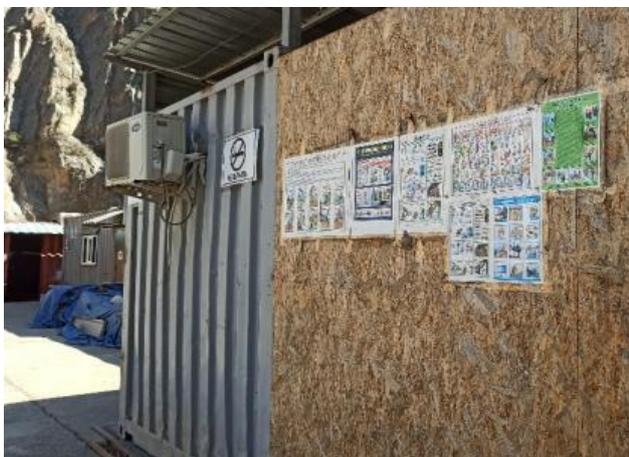
Figure 4. Health and Safety Informative board at site of CC ZMEC (Status in September 2021)

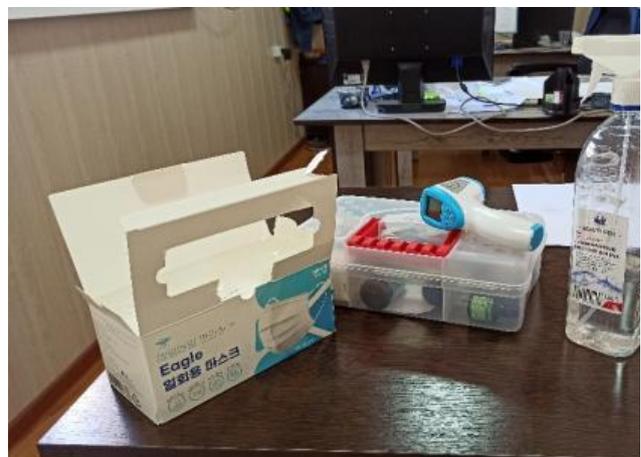
Figure 5. Antiseptic, masks, first aid kit are available at field office of CC ZMEC (Status in September 2021)

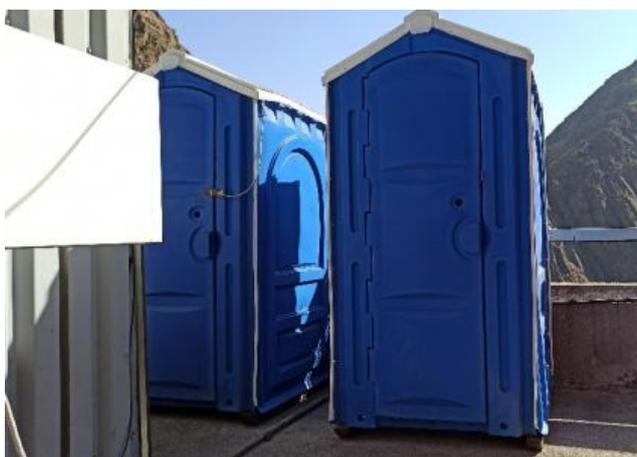
Figure 8. Composting toilets of CC ZMEC at work area (Status in September 2021)

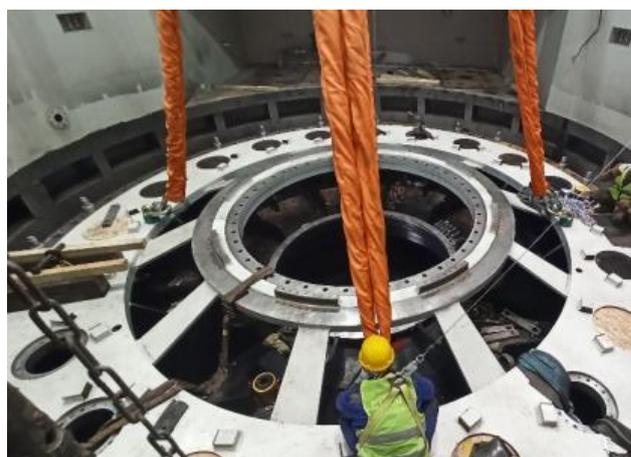
Figure 9. Workers of CC GE worked wearing PPE (Status in November 2021)

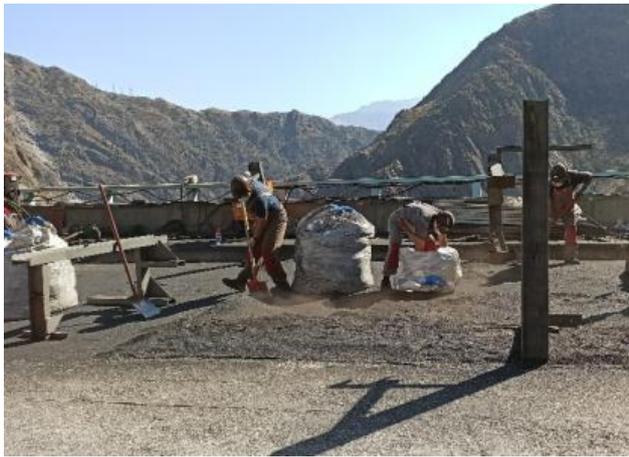
Figure 10. Workers of CC ZMEC worked wearing PPE (Status in September 2021)

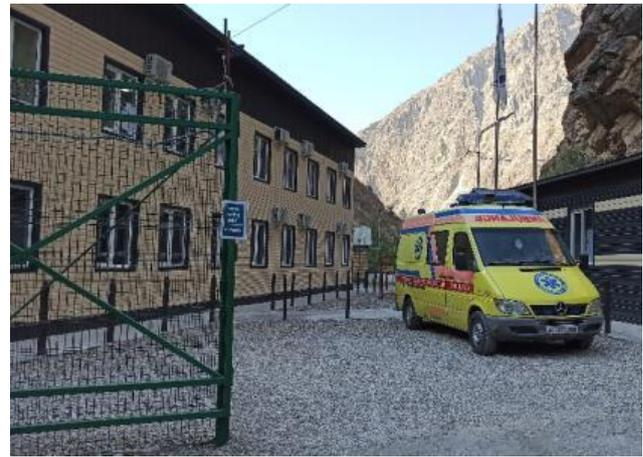
Figure 11. Medical station and ambulance for CC GE workers at site (Status in September 2021)

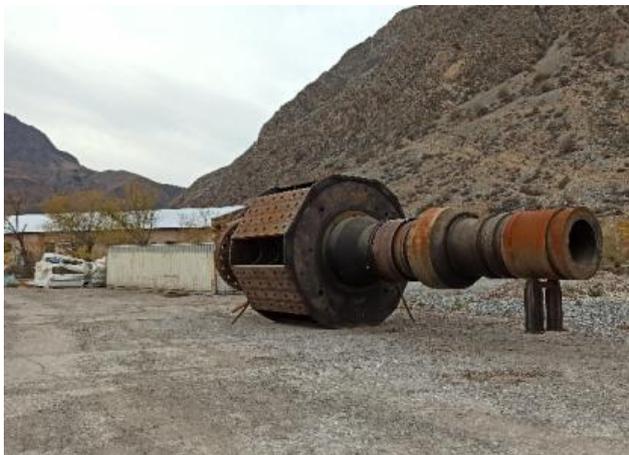
Figure 12. Scrap metal is at the storage area of Toktogul HPP (Status in November 2022)

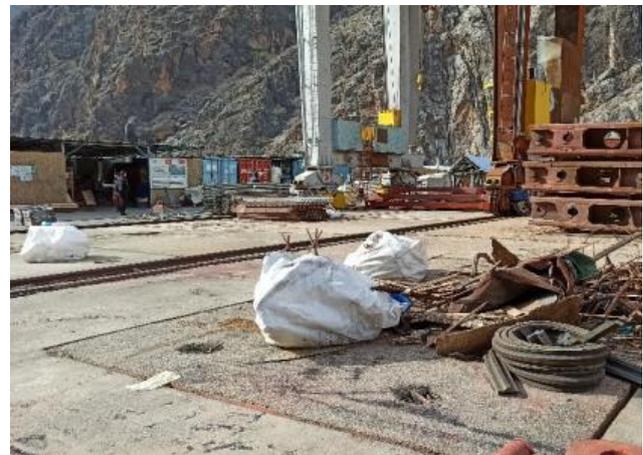
Figure 13. Construction waste and scrap metal are at site of CC ZMEC before disposal at the storage area of Toktogul HPP (Status in November 2021)

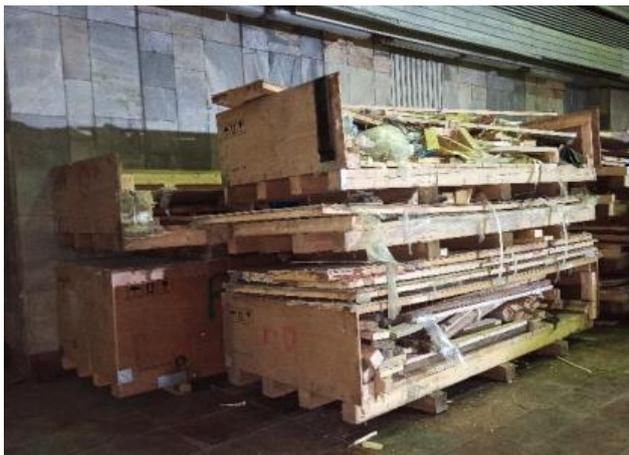
Figure 14. Wooden packing materials of new equipment were handed over to the Employer for secondary use (Status in September 2021)

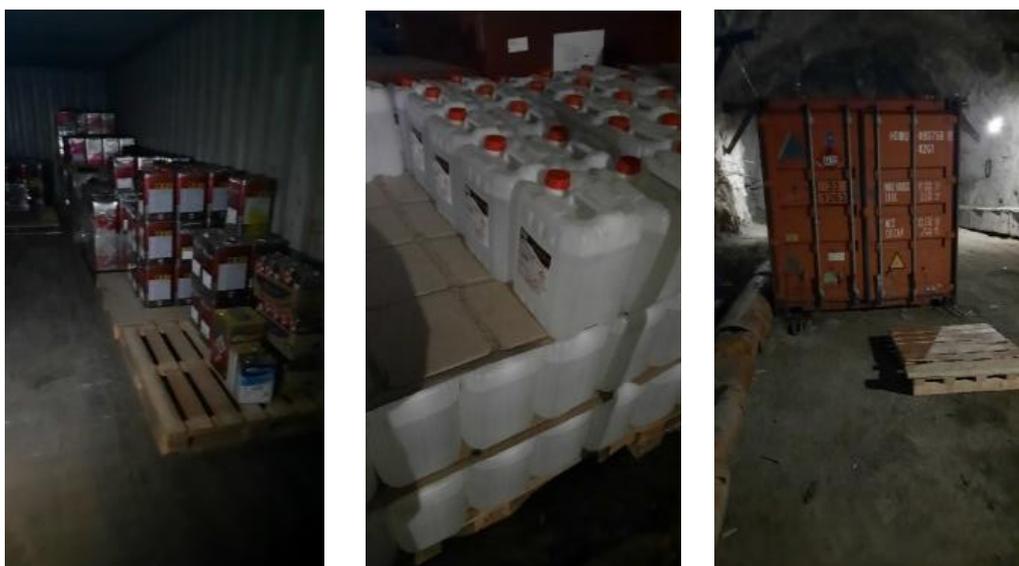
58. Storage area for cans of paintings located in a tunnel, on the access road to the dam, right bank was checked. It was observed that the cans of paintings and solvents were stored in a container and nearby, within the tunnel, where temperature was monitored and under access control. However, secondary containment was missing. This issue was discussed with CC ZMEC EHS Officer, and will need further development for protection from any spill.

Figure 16: Cans of paintings and solvent storage at Toktogul HPP (Status in December 2021)

57. An official letter has been sent to the Contractor of Package N°1 regarding the need to improve the storage of the cans of painting and solvents at site in September 2021. The technical arguments proposed by CC ZMEC in their answer were discussed with PIC international expert. It could be seen that storage of cans of paintings were improved at the dam crest, but still second containment was missing, convenient for small quantities (retention tanks).

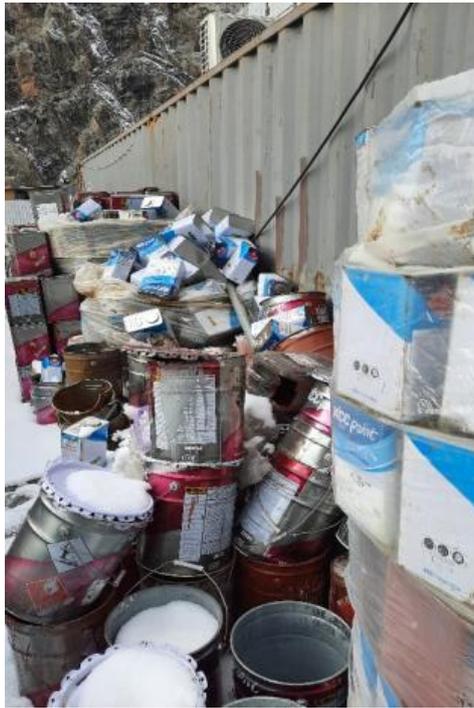
59. Empty cans of paintings and solvents which were used for the works are temporarily stored at the dam crest, waiting for handing over to the Cascade of Toktogul HPP. The storage place is temporary but still non convenient as empty cans remain a potential pollution source. They should be stored in dedicated watertight and closed skips. CC ZMEC has requested authorization to hand over these metallic wastes to the Client. EHS Officer of ZMEC is working to solve this issue with direct contacts with Cascade of Toktogul HPPs and it will be solved as much as possible in effective way.

Figure 17: Temporary storage of empty paintings cans of CC ZMEC at site
(Status in December 2021)

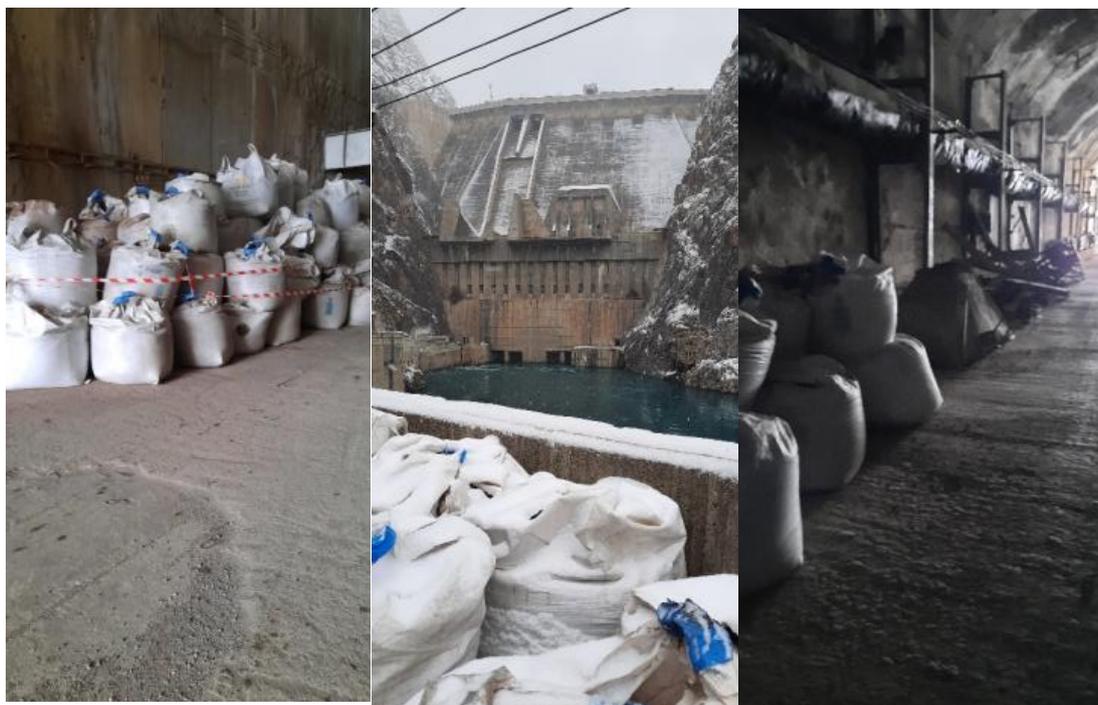
60. Abrasive waste coming from abrasive works were stored in big bags and temporary stored in crest tunnel, near dam entrance and the nearby tunnel (Figure 18). According to the appropriate agreement between CC ZMEC and the Cascade of Toktogul HPPs, this waste is displaced to the official landfill in Kara-Kul and transported on a regular base.

Figure 18: Temporary storage of abrasive waste of CC ZMEC at site
(Status in December 2021)

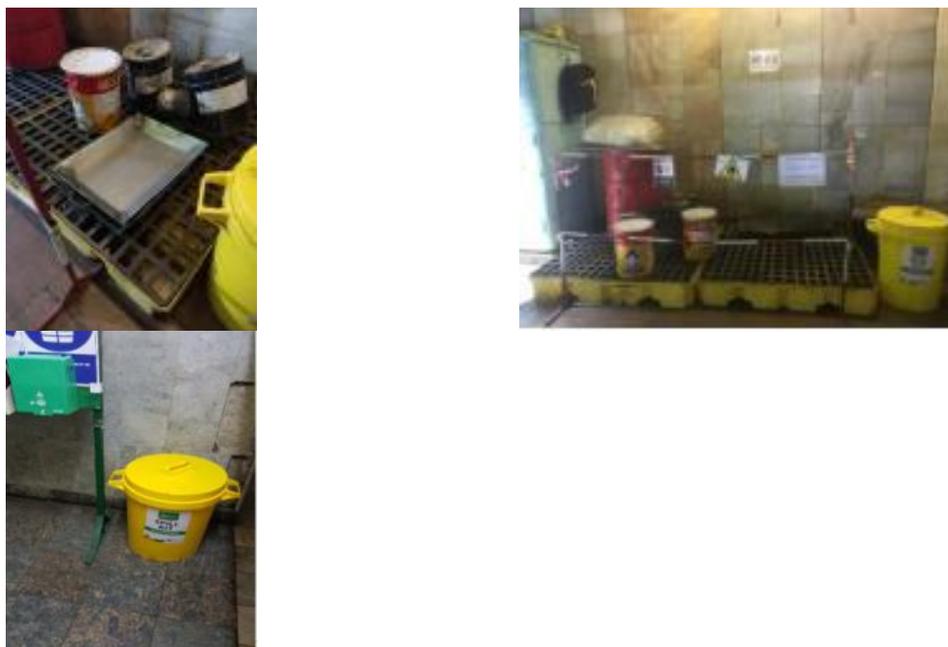
Figure 22: Secondary containment below chemicals, spill kit (Status in August 2021)

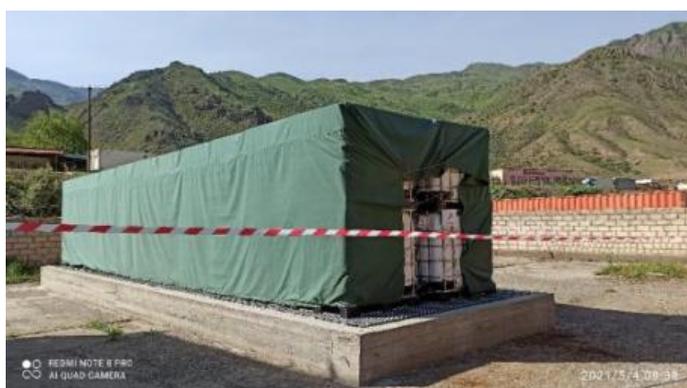
Figure 23: Storage of new technical oil of CC GE at site (Status in September 2021)

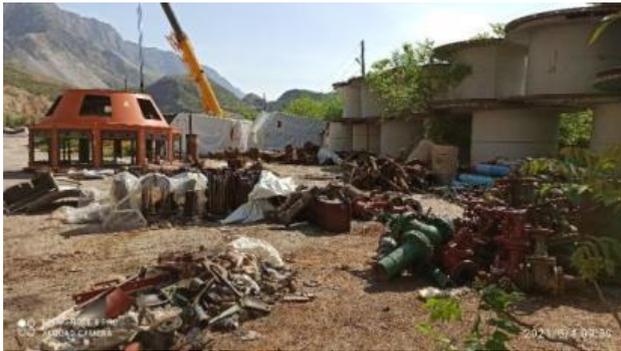
Figure 24. Designated area for construction waste and dismantled equipment at site (Status in July 2021)

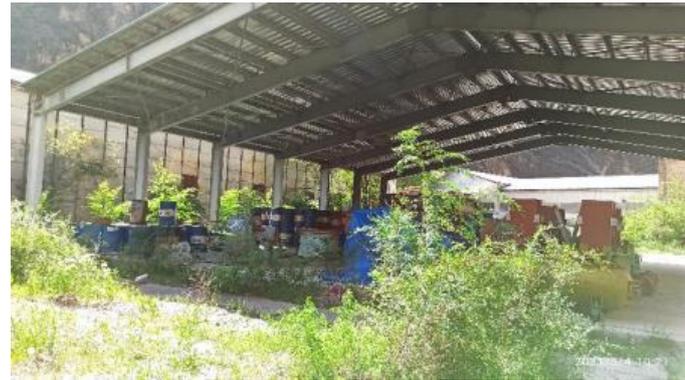
106. Drained used oil storage area was prepared during the 1st Phase of the Project. Oil storage is located on the site 16 of Toktogul HPP, its approximate dimensions are 25x25. It is a covered, well ventilated area with a concrete foundation (Figure 25).

Figure 25. Temporary oil storage area No.16 at Toktogul HPP (Status in July 2021)

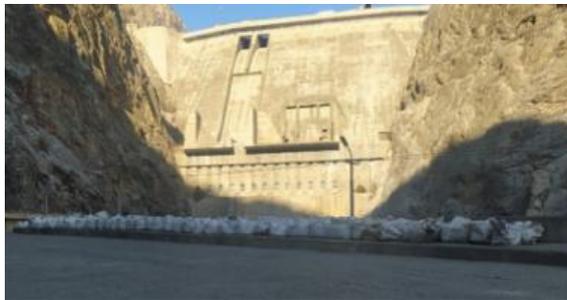
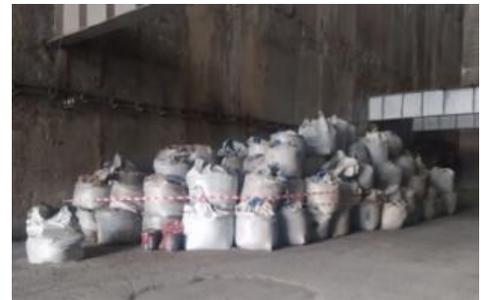
Figure 26: Temporary storage of abrasive waste (Status in December 2021)

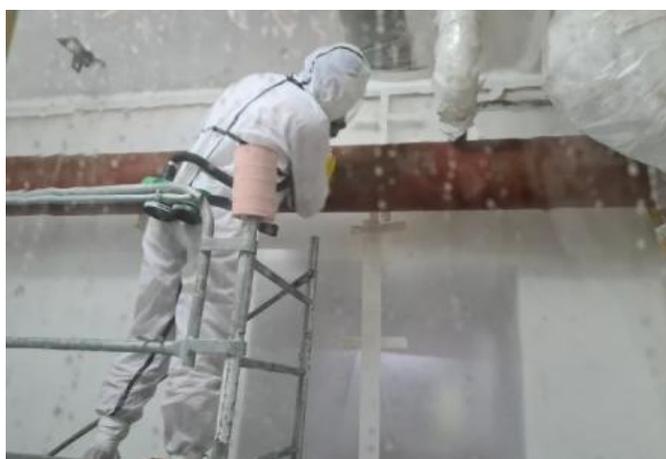
Figure 27. Asbestos cleaning work at Toktogul HPP project site (Status in September 2021)

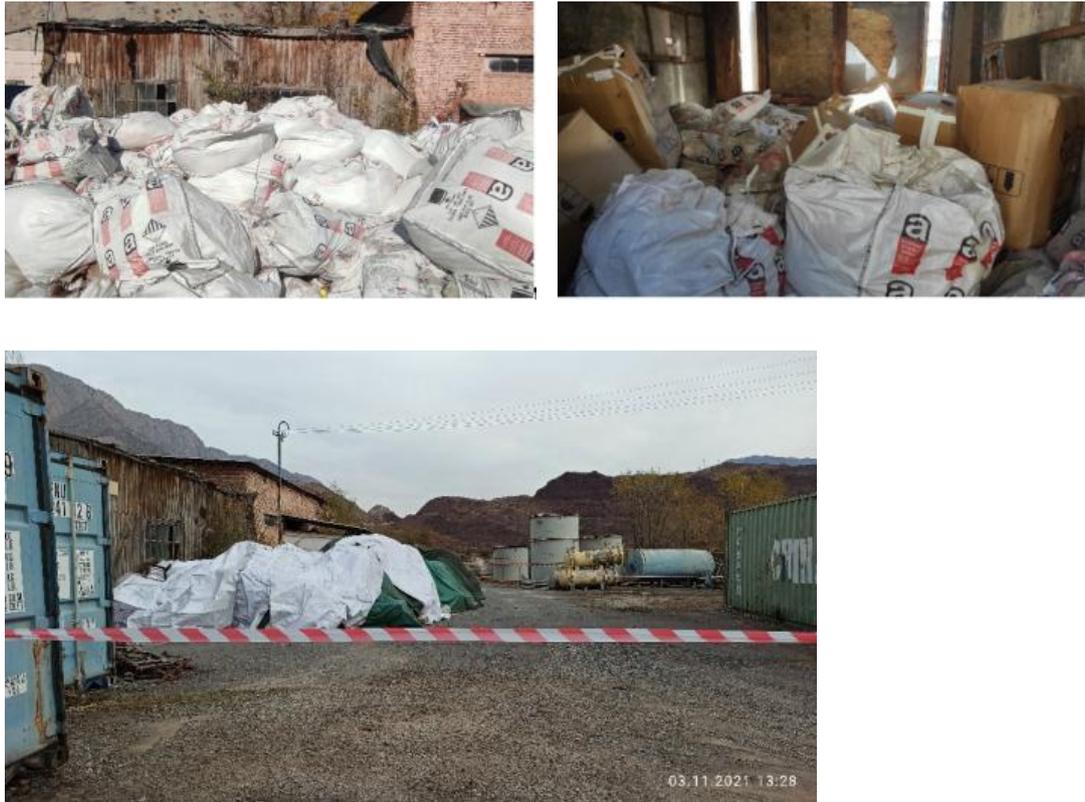
Asbestos containing waste/dismantled parts of equipment/used PPE were put in proper waste bags with the hazard warning signs as required by ACMMP and placed at the dedicated Customer storage area of Toktogul HPP. Bags with asbestos waste were covered by a tarpaulin temporarily (Figure 28).

Figure 28: Storage of asbestos waste at storage area of Toktogul HPP (Status in November 2021)

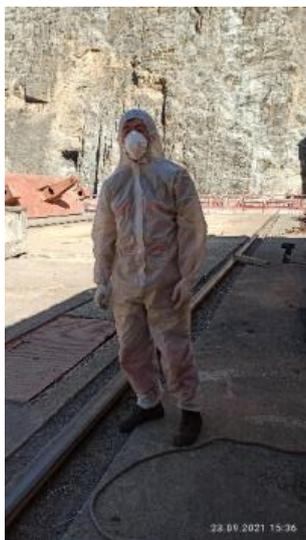
121. Dust-free cleaning of surfaces is used with a dust-free abrasive blasting machine. The abrasive is reused in case of spraying at the workplace, since the equipment allows collecting the sprayed abrasive back by means of the built-in "vacuum cleaner" (Figure 29).

Figure 29. PPE of a worker of CC ZMEC for work with blasting machine at site (Status in September 2021)

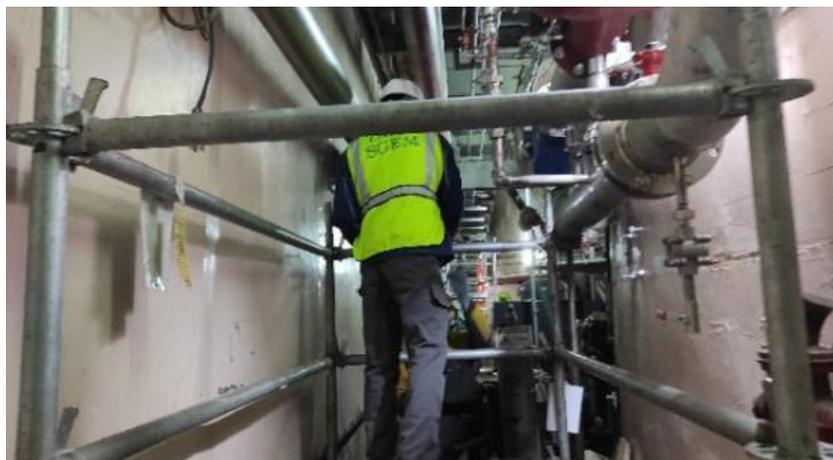
- Tajik SGEM: April 2021: Score of 36%, September 2021: Score of 40%. The need for further development and improvement is clear (Figure 32).
 - DIE: April 2021: Score of 76%, September 2021: Score of 62%

- These results show the low HSE culture of Tajik SGEM and the decrease of HSE performance of DIE.

Figure 32: Work on scaffolding by GE's subcontractor Tajik SGEM (Status in December 2021)

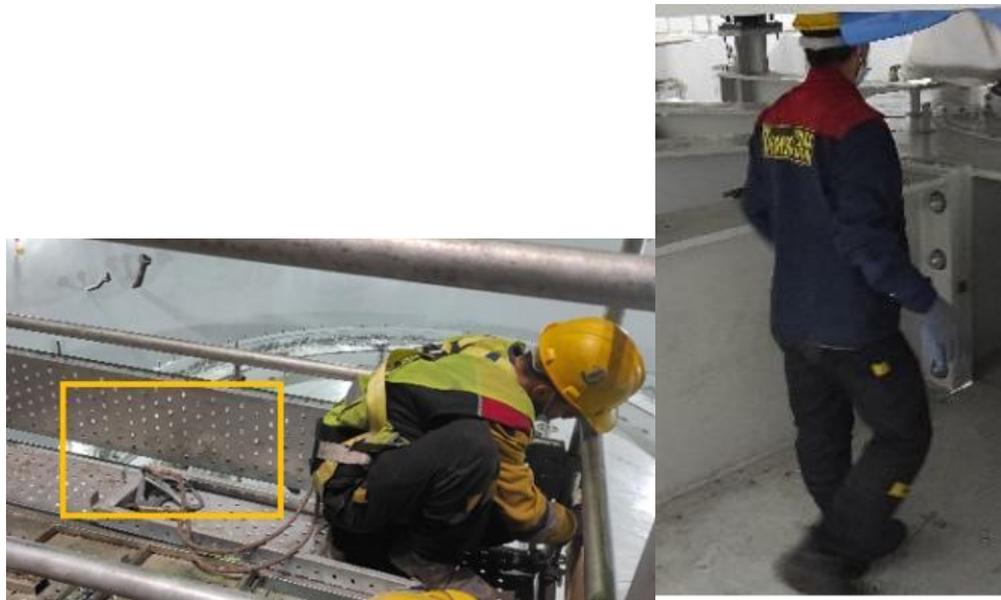
- Some workers were identified as working at height with improper use of harness and lanyards. Safety cable not adequately fixed and no visibility vest by GE's subcontractor TajikSGEM (Figure 33).

Figure 33: A worker of GE's subcontractor Tajik SGEM working at site (Status in December 2021)

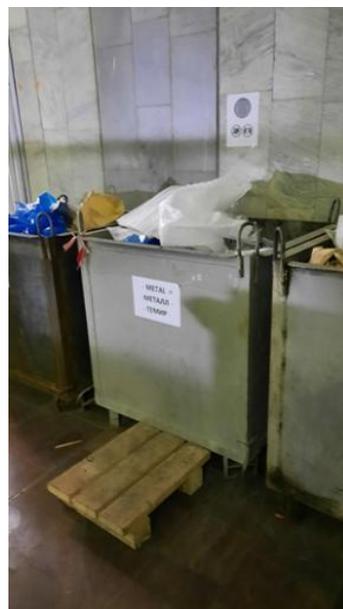
Figure 37: Waste segregation by CC GE at site (Status in December 2021)

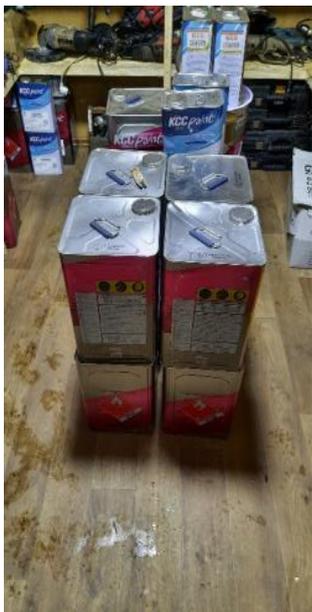
Figure 38. Storage of paintings without containment at CC ZMEC site (Status in December 2021)

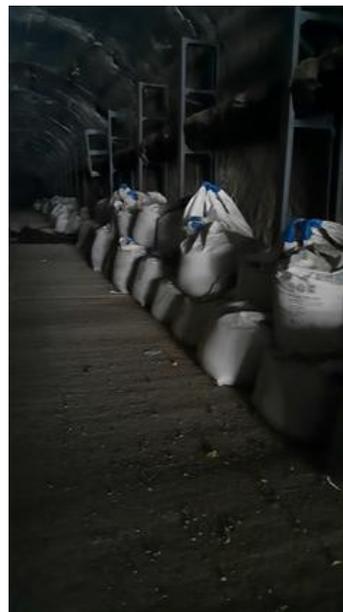
Figure 39: Temporary storage of abrasive waste within tunnel at CC ZMEC site (Status in December 2021)

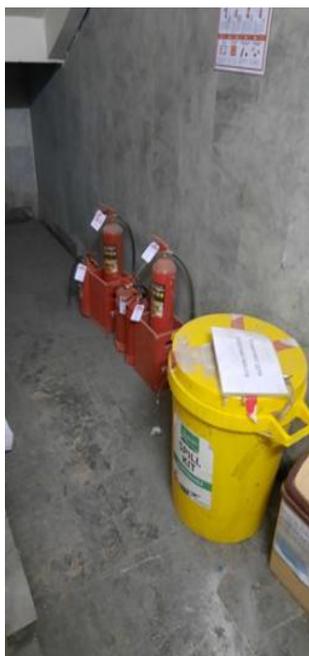
Figure 40: EHS equipment within working areas of CC ZMEC (Status in December 2021)
