Environmental Monitoring Report

Semi-annual report
January - June 2023

Kyrgyz Republic: Toktogul Rehabilitation Phase 2 Project

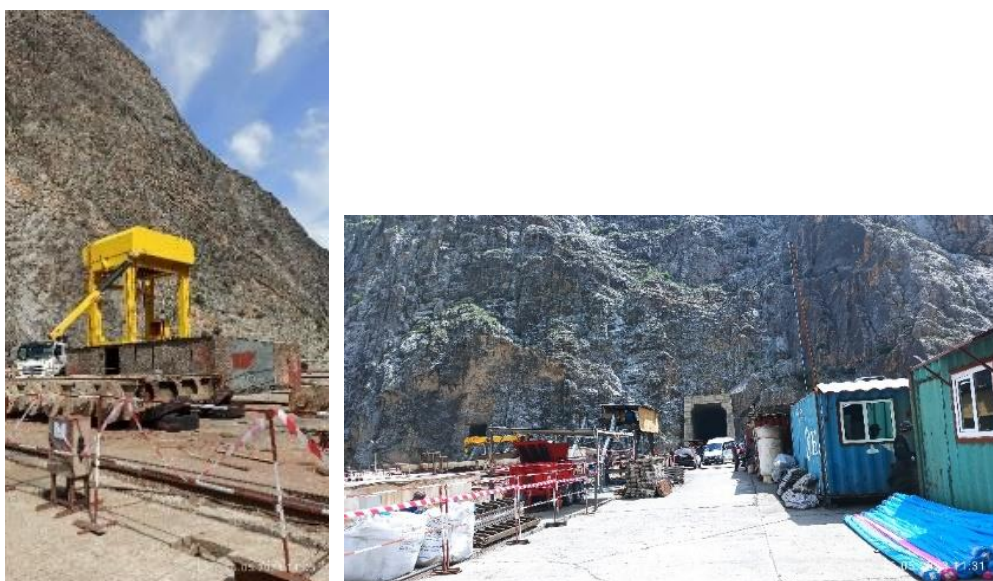
Rehabilitation work is carried out strictly on the allotted area of the Cascade of Toktogul HPP according to design and schedule of work. Health and safety measures were fully implemented by CC ZMEC of Package 1. Each worker was provided with appropriate PPE. No accident was occurred during reporting period. Meetings with HSE specialist of CC ZMEC were held with discussion of health, safety and environment measures implementation at the field office of CC ZMEC.

Figure 2. Work areas of CC ZMEC were fenced and clean (Status in May 2023)

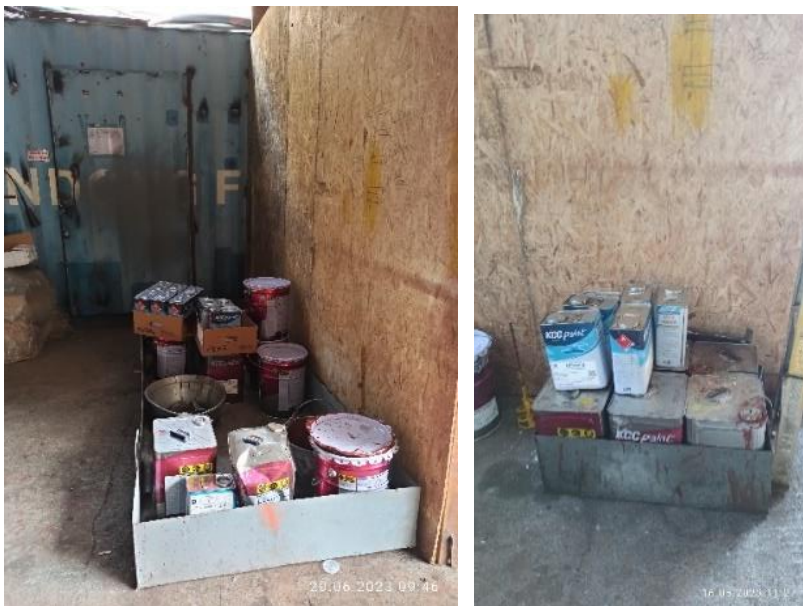
Figure 6. Chemicals/painting were stored with secondary protection at site of CC ZMEC (Status in May and June 2023)

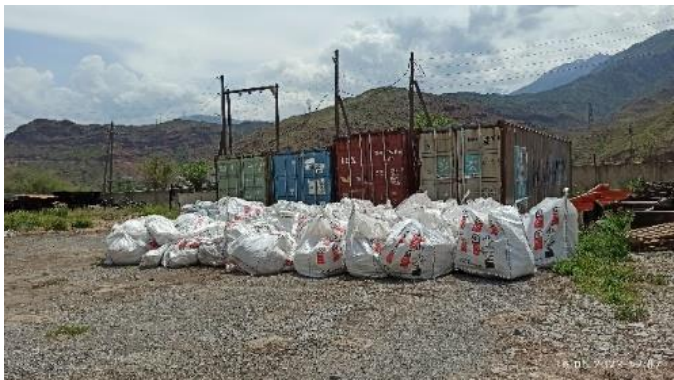
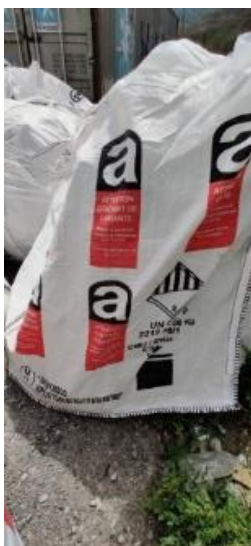
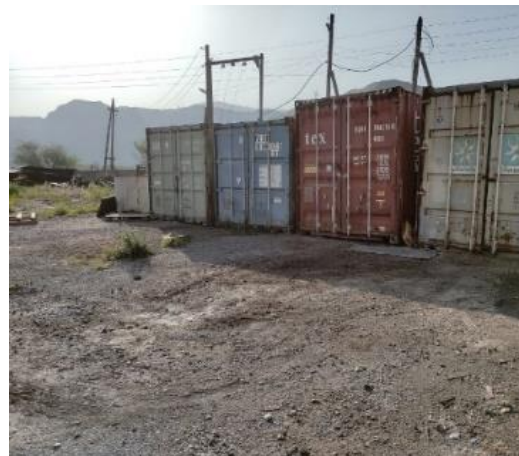
Asbestos containing waste was collected in double bags/asbestos marked bags at asbestos cleaning area of Toktogul HPP, and transported to the designated storage area of Toktogul HPP. There were designated containers for asbestos containing bags at the storage area. But in 16 May of 2023, bags were left next to the containers in open air (Figure 18.).

Figure 18. Openly stores asbestos waste bags at Toktogul HPP storage area (Status in 16 May 2023).

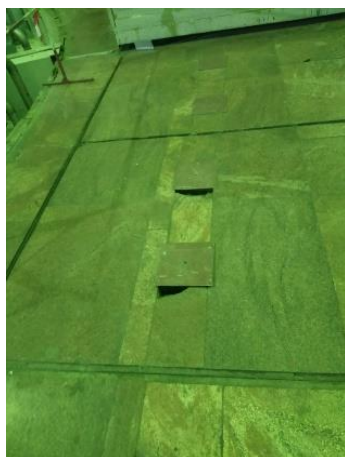
67. Broken area in machine hall section of Toktogul HPP was a tripping hazard. It is a site area of CC GE. Immediately that broken area was repaired and fixed by a team of CC GE under HSE manager supervision of CC GE (Figure 21).

Figure 20. Broken floor area in the Machine Hall of Toktogul HPP (Status in May 2023)

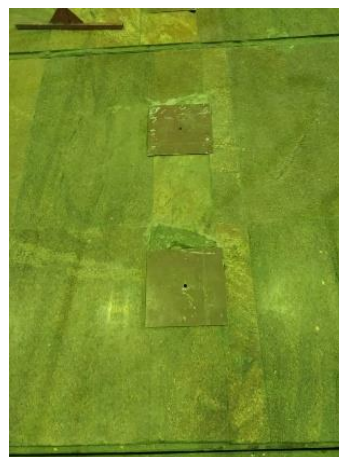
Figure 21. Repaired floor area in Machine hall of Toktogul HPP (Status in May 2023)

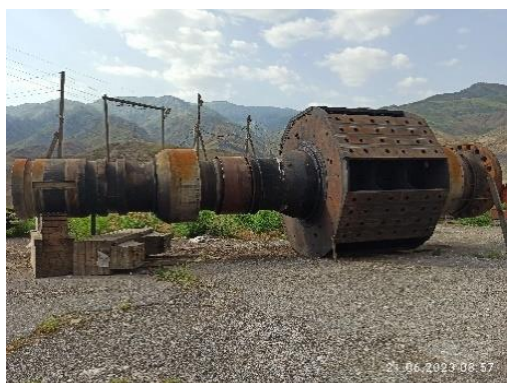
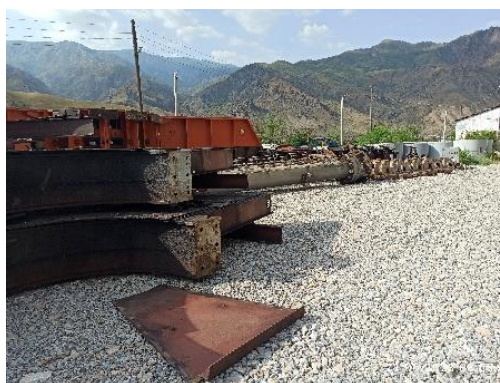
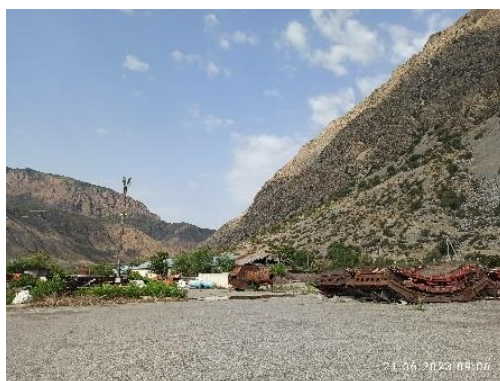
68. Dismantled equipment is stored at designated storage area of Toktogul HPP. It is a partially asphalted, fenced, secured area and no admittance except business. Site visits did not reveal any oil spills under dismantled equipment (Figure 22).

Figure 22. Storage area of dismantled equipment of Toktogul HPP (Status in June 2023)

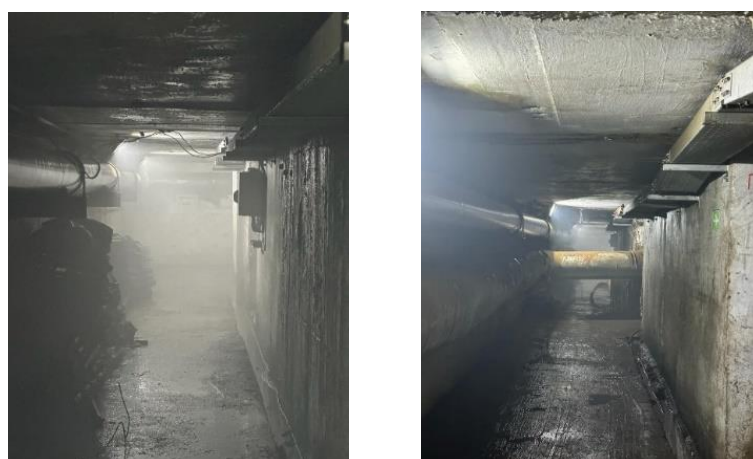
71. During the reporting period, one non-conformity report (NCR) was issued regarding the air pollution due to the sandblasting works of Unit 3 penstock on elevation 707. Sandblasting works were implemented by CC SM ZMEC (Figure 25).
72. Contractor of Package 2, GE has sent an official email with compliance to the Employer dated 23.06.2023. Due to sandblasting, which led to the dust pollution of the elevations 707m, 710m and 713m it complicated the work of TajikSGEM employees and caused to stop of works on above-mentioned elevations.

Figure 25. Polluted air on elevation 707 m during sandblasting works of CC ZMEC (Status in June 2023)

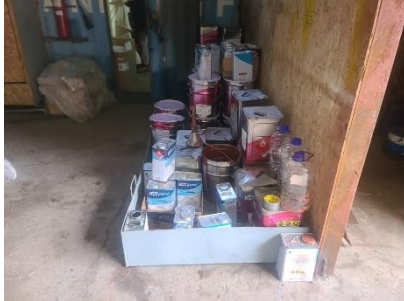
94. Storage of chemicals, mainly paintings and solvents were equipped with secondary containments (Figure 26). Anti-spill material, sand, was available at storage area.

Figure 26. Secondary containment of chemicals at storage area of CC ZMEC (Status in January 2023)

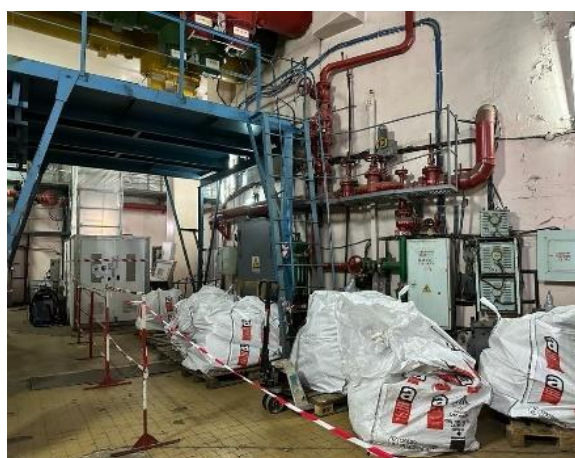
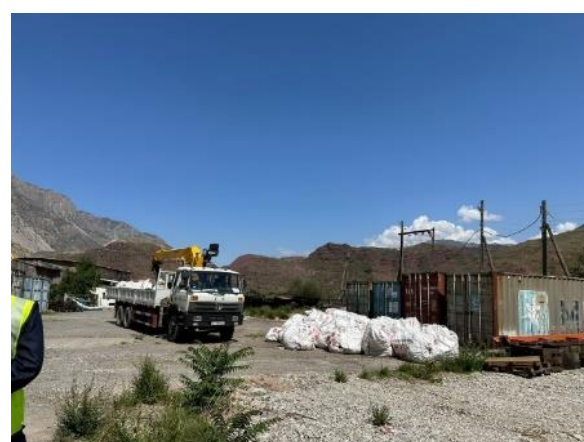
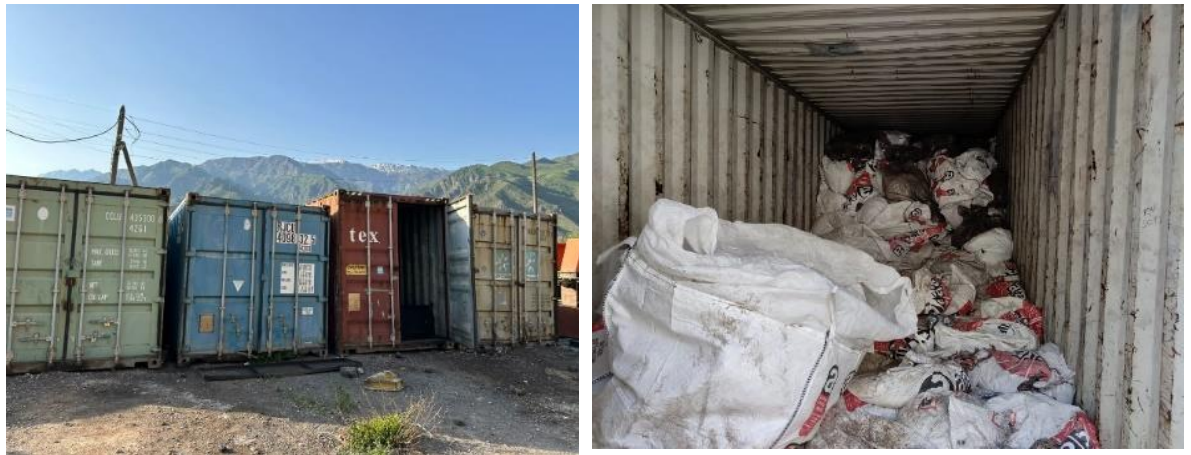
- 118. Asbestos containing waste/dismantled parts of equipment/used PPE were put in proper waste bags and placed at the dedicated Customer storage area of Toktogul HPP. Asbestos storage is under the Customer responsibility. All waste bags with asbestos stored in the containers, which are sealed (Figure 32).

Figure 32. Collection of ACM waste bags and storage of asbestos waste at the designated storage area (Status in June 2023)

120. Based on this, ACM waste will be stored at the Employer storage area until the legal rules are updated. The Employer keeps this issue under control. Conditions of reuse of some contaminated material should also be studied, including safety measures.
