# Bi-Annual Environmental Monitoring Report

Project Number: 44198 – KGZ  
ADB Loan/Grant Number: L2869/G0294-KGZ  
Reporting period: January–June 2018

## **Kyrgyz Republic: Power Sector Rehabilitation Project, Phase 1**

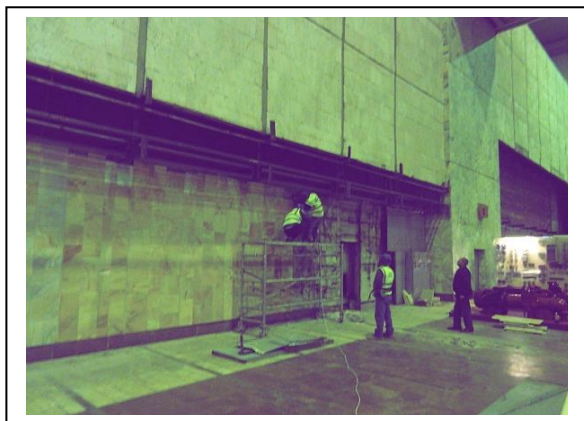
Picture 2: Workers are removing tiles as they dismantle the wall in front of main transformer 1 (Status in April 2018)

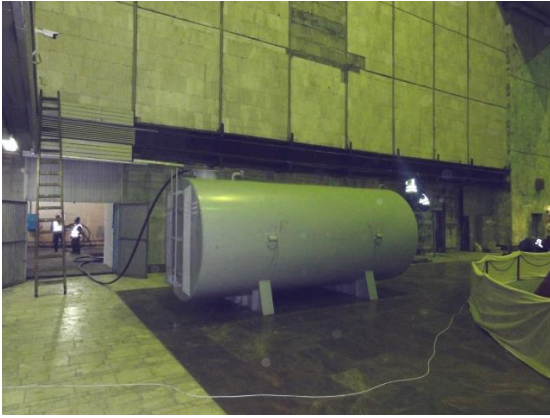
Picture 3. Oil taken from main preparatory work to transformer 1 and stored in tanks (Status in April 2018).

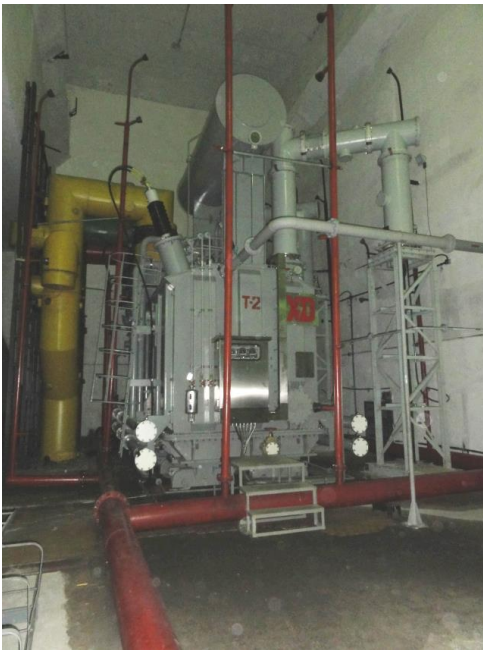
Picture 4. Main transformer 2 in operation (Status in April 2018)

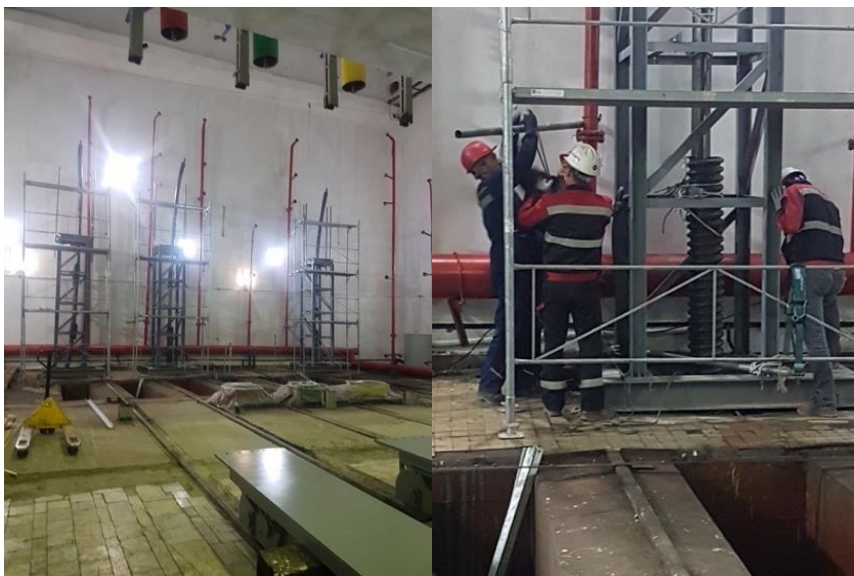
Picture 5. Main activities comprised the installation of T1 Transformer (Status in May 2018)

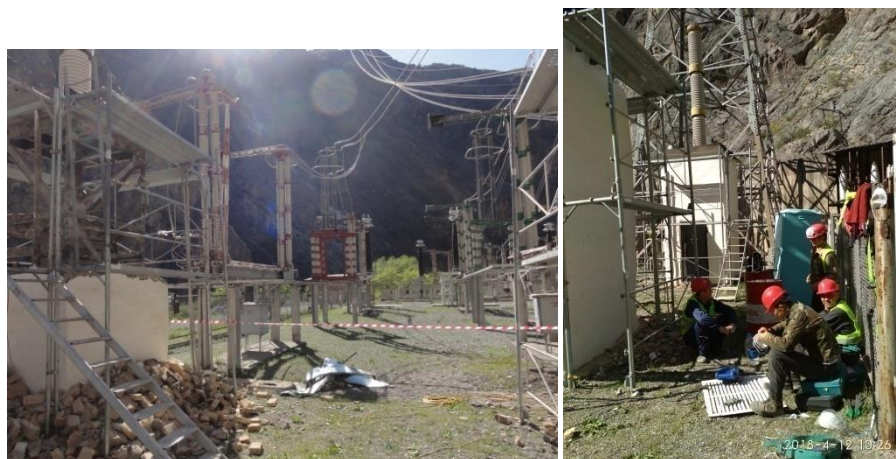
Picture 6. Works at transition point (Status in April 2018)

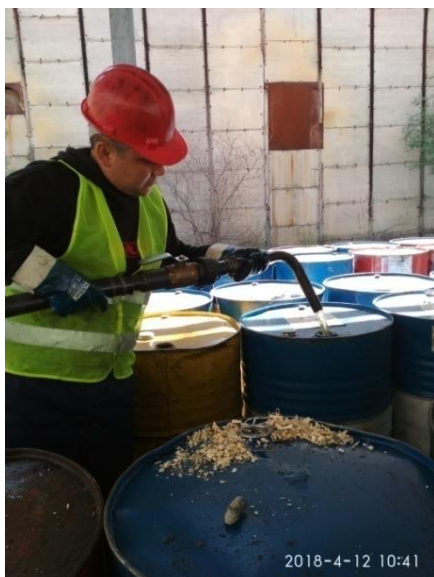
Picture 7. Removal of oil from HV cable of Unit 1 (Status in April 2018).

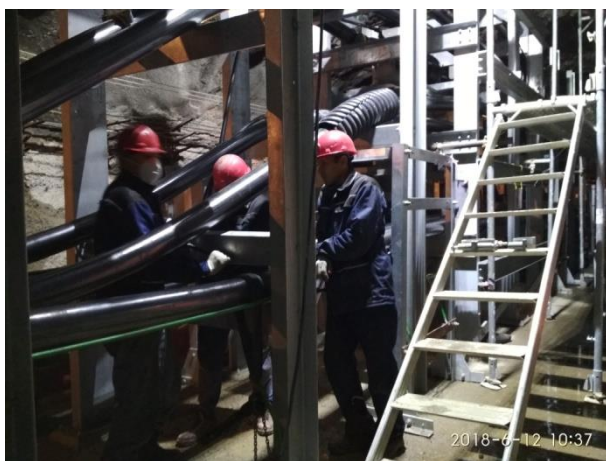
Picture 8. Works at cable tunnel (Status in June 2018).

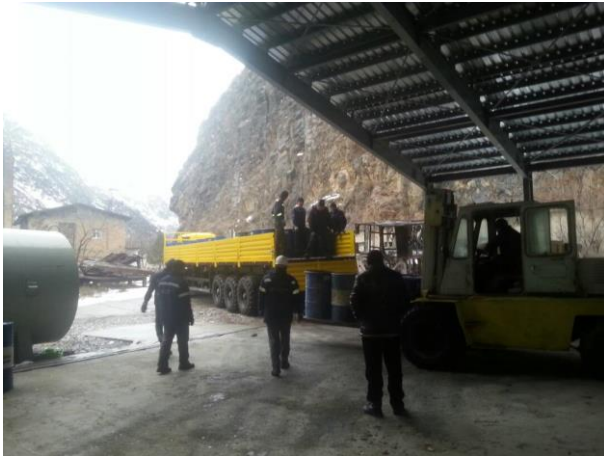
with oil from Toktogul HPP to Osh TPP was done by two truck rides. No any accident happened on the way (Picture 9).

Picture 9. Downloading of barrels with cable oil to trucks at Toktogul HPP oil storage facility (Status in February 2018).

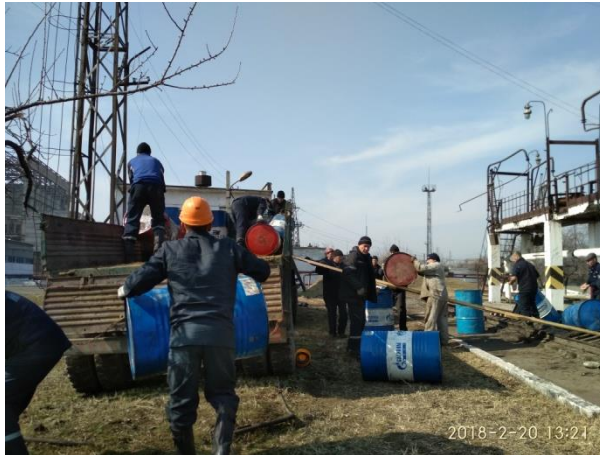
47. Annex 4). Cable oil was drained in to oil facility of Osh TPP and it was implemented in compliance with health, safety and environment protection requirements (See pictures 10, 11).

Picture 10. Unloading of barrels with cable oil at Osh TPP (Status in February 2018)

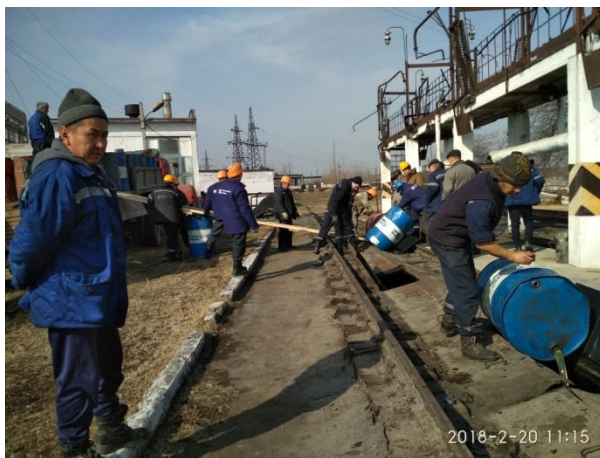
Picture 11. Cable oil draining from barrels to oil facility of Osh TPP (Status in February 2018)

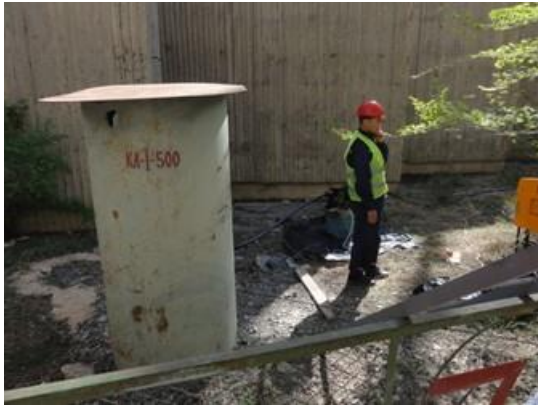
50. During this site inspection the main activities have been the removal of oil from cable and from main and auxiliary transformers from Unit 1. It was found that this was done properly, some smaller oil leakages have been observed. The oil was immediately bound by saw dust or hindered to pollute the soil by covering the earth with plastic tarpaulins.

Picture 12: Extraction point of cable oil Unit 1 (Status in April 2018)

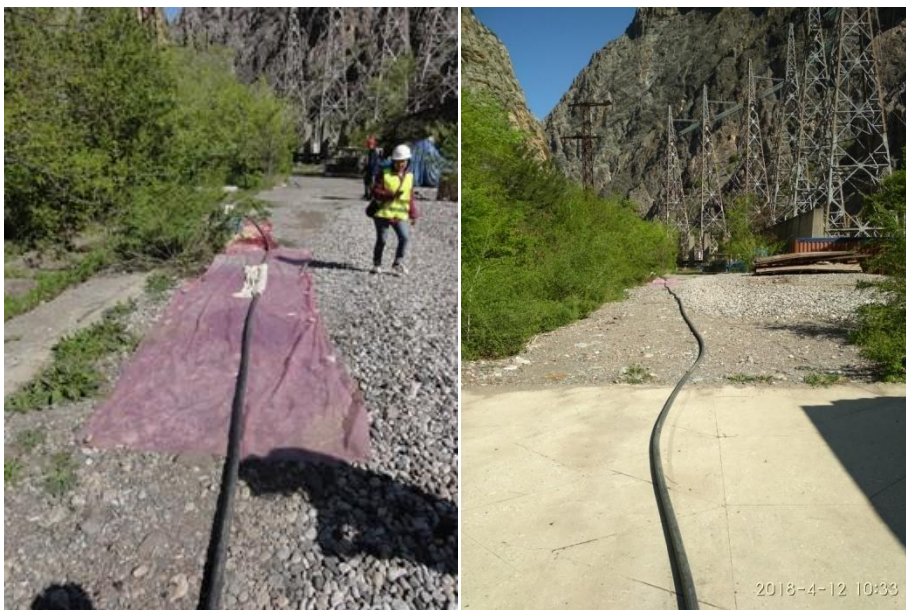
51. As planned, the pipeline for draining the cable oil in the barrel was installed. The oil from the upper part of the cable was drained to the barrels via the transfer point. The outcomes of the implemented work demonstrated that the selected way of the oil drain was reliable as it reduced the risks of oil spills and saved the time and effort of the workforce. No significant oil leaks took place and all the works passed sustainably. Possible oil pollution prevention is done by using plastic tarpaulin and saw dust. (Pictures 12-15). Further polluted saw dust was removed to base 3 jointly with other construction waste. And plastic can be reused for the next and final dismantling works of Unit 4's cable line.

Picture 13: Hose in which cable oil is pumped to the drums (Status in April 2018)

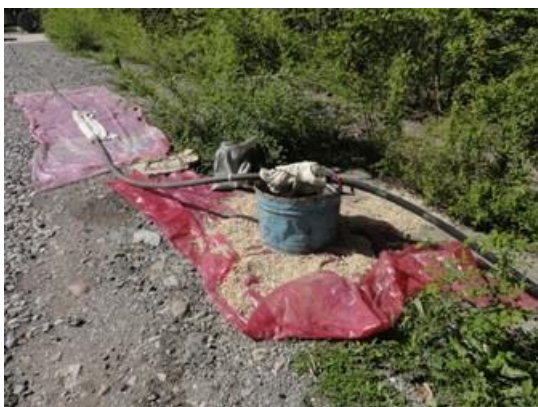
Picture 14. Using plastic tarpaulin and saw dust to prevent minor oil pollution (Status in April 2018).

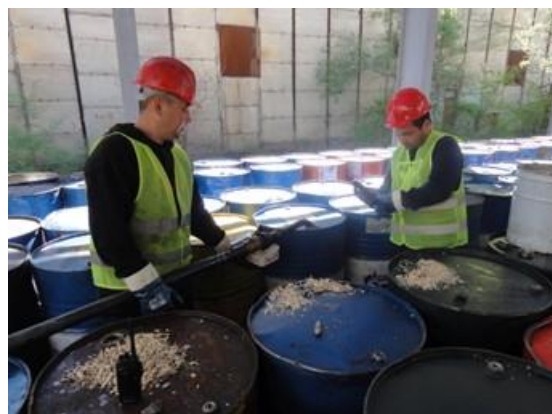
Picture 15. Workers filling of cable oil into the drums wearing PPE and proper gloves (Status in April 2018).

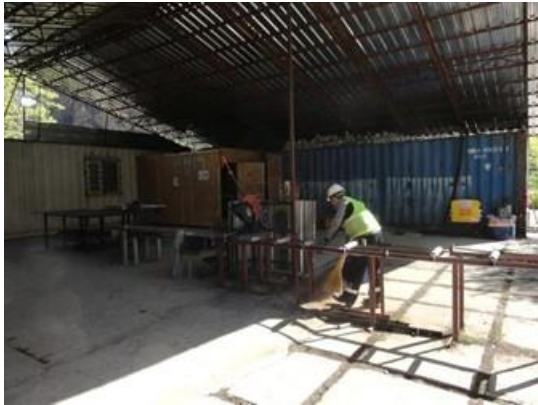
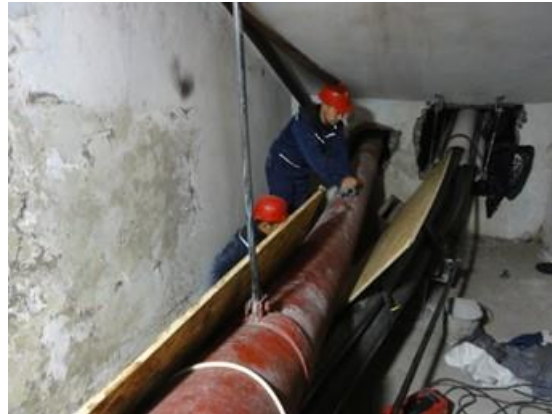
53. The construction sites inside and outside the power house looked quite tidy and clean and have been well organized. Most of Korean and Chinese workers wear all needed PPE (Picture 16).

Picture 16. Worker in assembly hall and workers in the cable tunnel wearing proper PPE (Status in April 2018).

It was requested again that the HSE officer from Chinese contractor perform daily tours to check that all safety warnings are respected and proper PPE is observed, including wearing ear plugs.

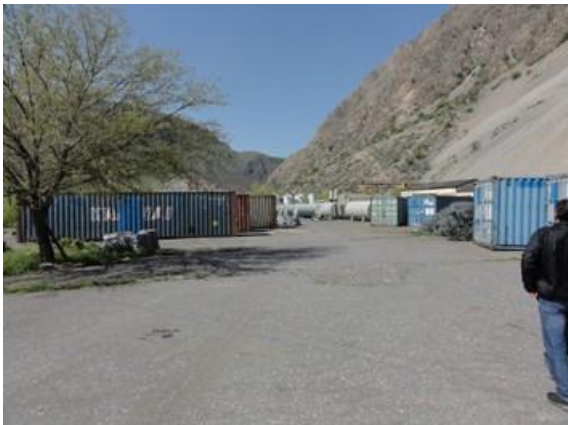
54. The dismantled cables of Unit 1 (after having removed the oil) are cut in pieces and stored in existing containers at the HPP storage site outside the fenced power plant area. The dismantled transformer T22 and used transformer oil are stored in this site as well (See pictures 17-19). At picture 18 the smaller tanks with transformer oil are completely new which arrived together with new transformers for Lot 2 works. Bigger tanks are intended for transformer oils. Secondary containment to contain transformer oils is available at Toktogul HPP.

Picture 17. EPP storage site outside the fenced HPP area. In foreground containers oil with cut dismantled cable, in background tanks with used transformer oil (Status in April 2018)

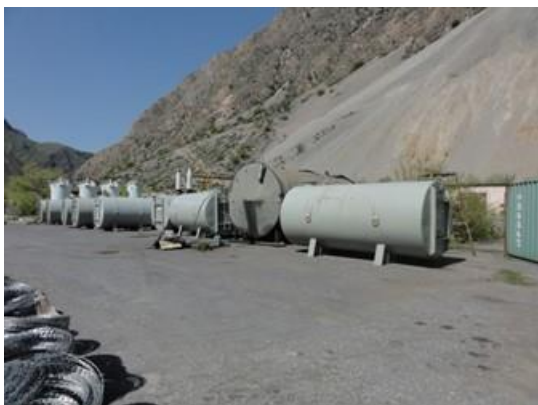
Picture 18. Tanks with used transformer oil (Status in April 2018)

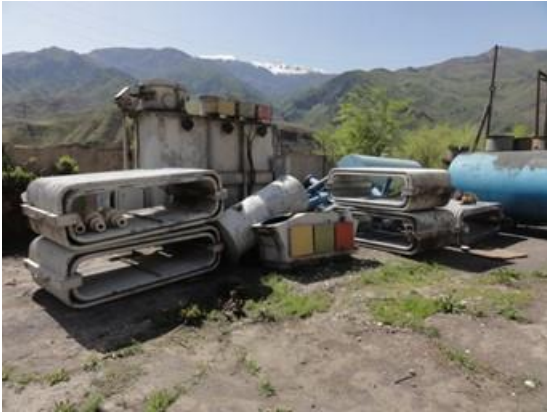
Picture 19. Old dismantled T22 Transformer (Status in April 2018).

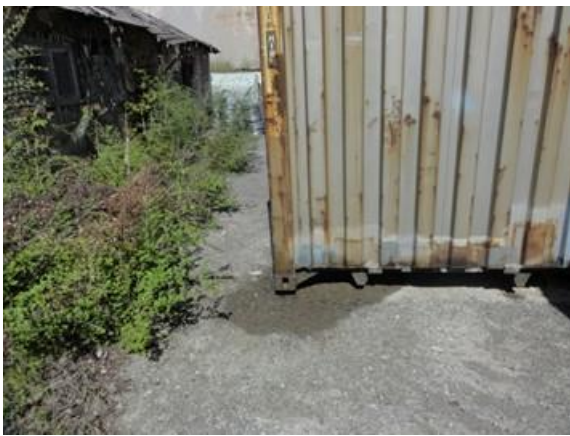
55. Nearby the storage tanks for transformer oil and containers with cable, some small oil leakages with sand have been observed on the site (Picture 20). This warehouse has an asphalted foundation.

Picture 20. Some small oil leaks nearby containers storing cut cable pieces (Status in April 2018).

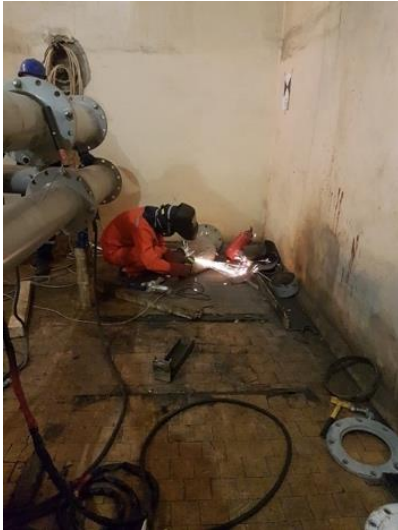
60. The room for the main transformer T-1 cooling system is fitted with fresh air and exhaust ventilation. It was noted that ventilation does not work steadily. In this regard, the Lot-2 contractor is responsible for the proper operation of ventilation in its sections and the compliance with the air quality standards in the work area. In terms of the OHS compliance, all workers are equipped and constantly use PPE. As an instance, a worker who performing welding works uses appropriate personal protective equipment, a mask, glasses, his head and neck are protected by a special helmet in below picture 21.

Picture 21. A worker performing welding works (Status in May 2018).

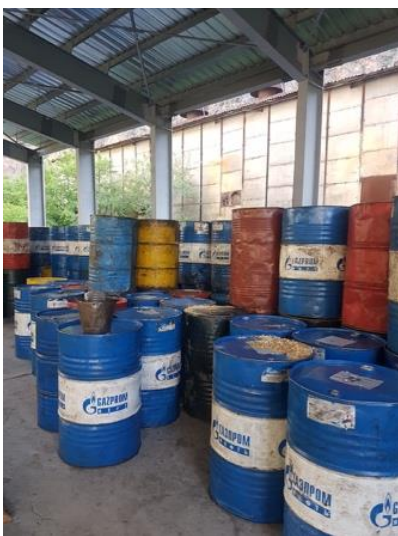
64. Oil storage area. The oil from the cable Unit 1 is currently kept at the oil storage area. Manager of the Korean contractor informed, there are 190 barrels of oil with 194 liters of oil in the oil storage area now, summing up to 36,860 liters (31,515.3 kg) of oil. In order to save free space on the oil storage area, where other equipment is temporarily also stored, empty barrels were placed in a second tier on barrels containing oil (Picture 22). With regard to the safety rules, it is permitted to install drums on top of each other, but not more than 2 tiers in height. There were no any leaks found at the oil storage area.

Picture 22. Barrels with oil from the cable line 1 with empty barrels on the top (Status in May 2018).

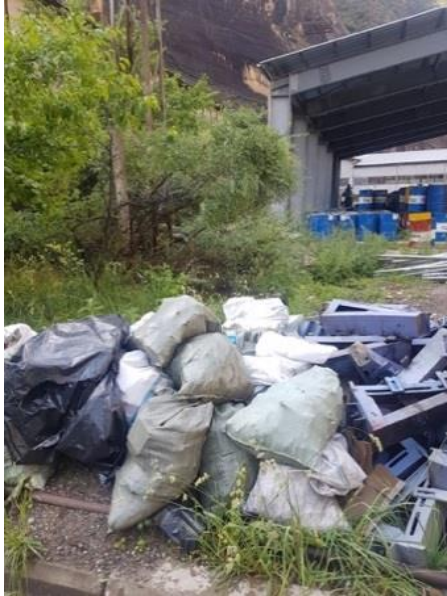
65. Domestic and construction waste. In the vicinity of the oil storage area, solid municipal and construction wastes, packaged in bags, are placed. Nearby, also scrap metal which might be

Picture 23. Construction waste in bags temporarily stored at site (Status in May 2018).

66. During the meeting with General site manager of SM Powertech for Lot 3, his attention was drawn to the fact that heaps of garbage, construction waste, and scrap are accumulating around the oil storage area. Garbage removal is carried out on a weekly basis, in accordance with the Contract with the Cascade of Toktogul HPP and responsible for garbage removal and disposal at the official land-fill during Project activities.

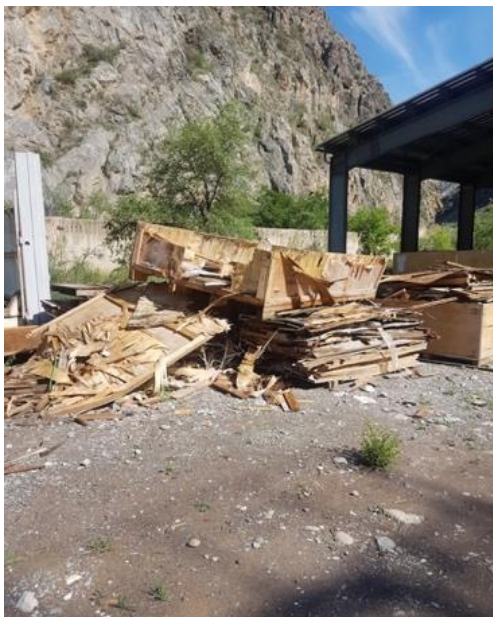
Picture 24. Wooden container next to the oil storage area temporarily stored at site (Status in May 2018).

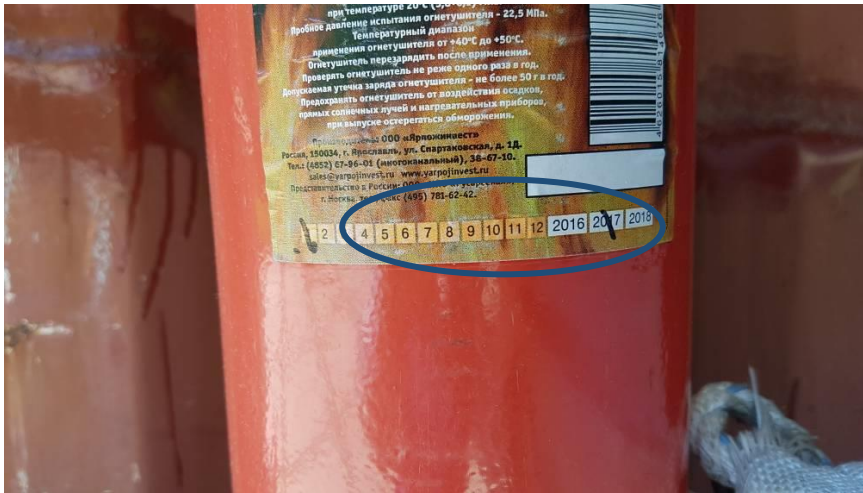
67. Fire shield and fire extinguisher. The consultant checked the fire shield, the presence of all necessary items, and the date of the last verification of the gas-type fire extinguisher. Manager of the Korean contractor informed the fire extinguisher was used only once, after which it was refueled, in March 2018. The date of the last verification, as follows from the fire extinguisher pointer - January 2017. The next verification was planned to take place in June this year (Picture 25).

Picture 25. Fire extinguisher, with specified dates and instructions for use, from the manufacturer (Status in May 2018).

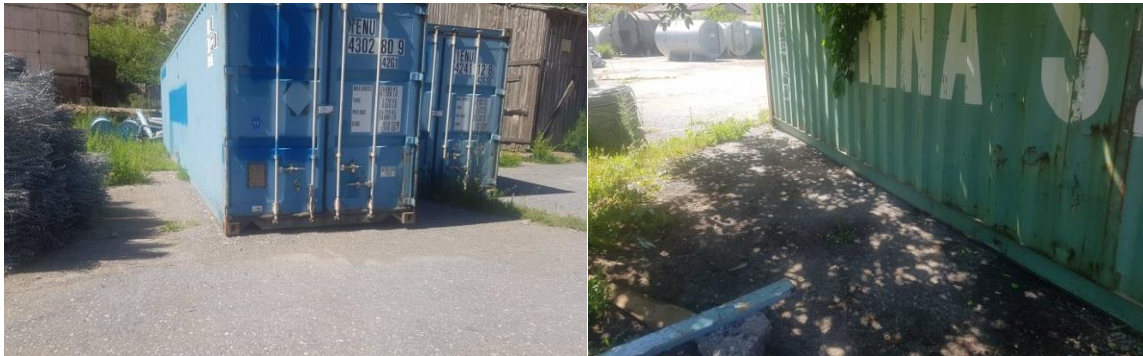
68. During the inspection visit, the consultant visited the warehouse, where the containers are located in which the dismantled cable is stored. Inspection showed that there were no serious oil leaks (Picture 26).

Picture 26. Containers where dismantled cable is kept. (Status in May 2018).

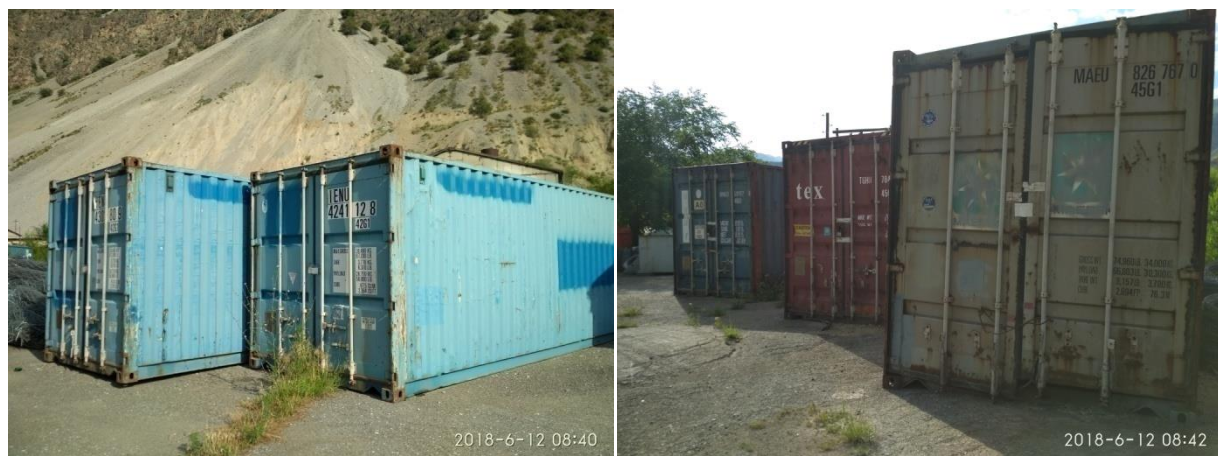
70. They visited the warehouse for storage of scrap metals, some parts of transformer oil, and containers with cable cut pieces (so-called warehouse No 3). Leaks of oil are insignificant, as previously. Those minor leaks which were found by the consultants, were fixed earlier, and were from the old containers. The relevant personnel constantly monitor the state of the containers, and the places with the minor leaks are sanded (Picture 26, 28). Tanks with transformer oil are in good condition.

Picture 27. Containers with cable cut pieces kept at warehouse (Status in June 2018).

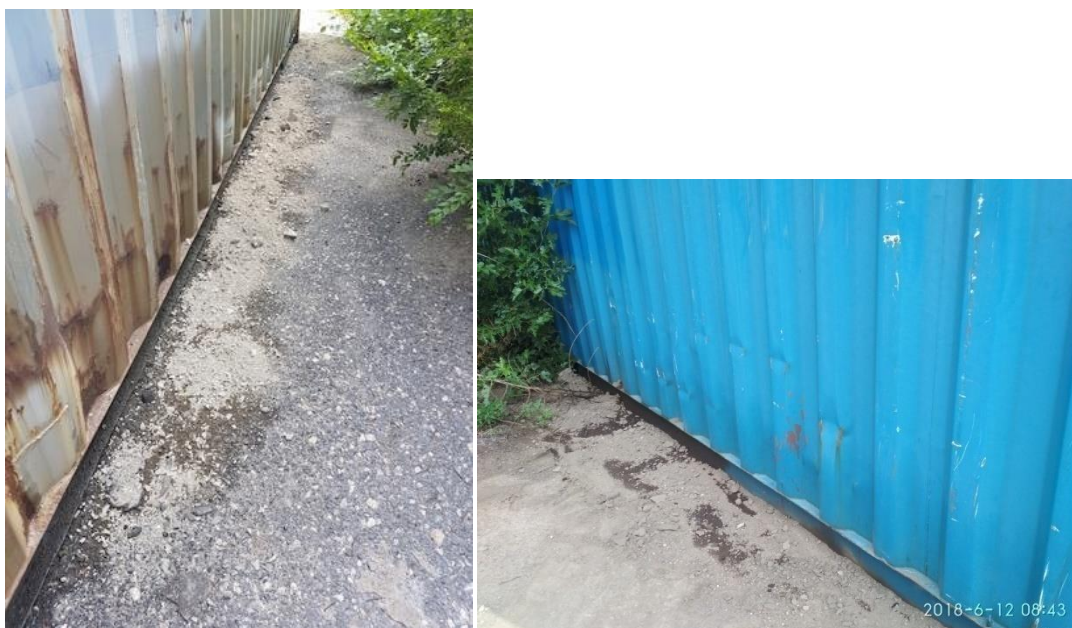
Picture 28. Small oil leaks on the asphalt coverage near the containers with cable (Status in June 2018)

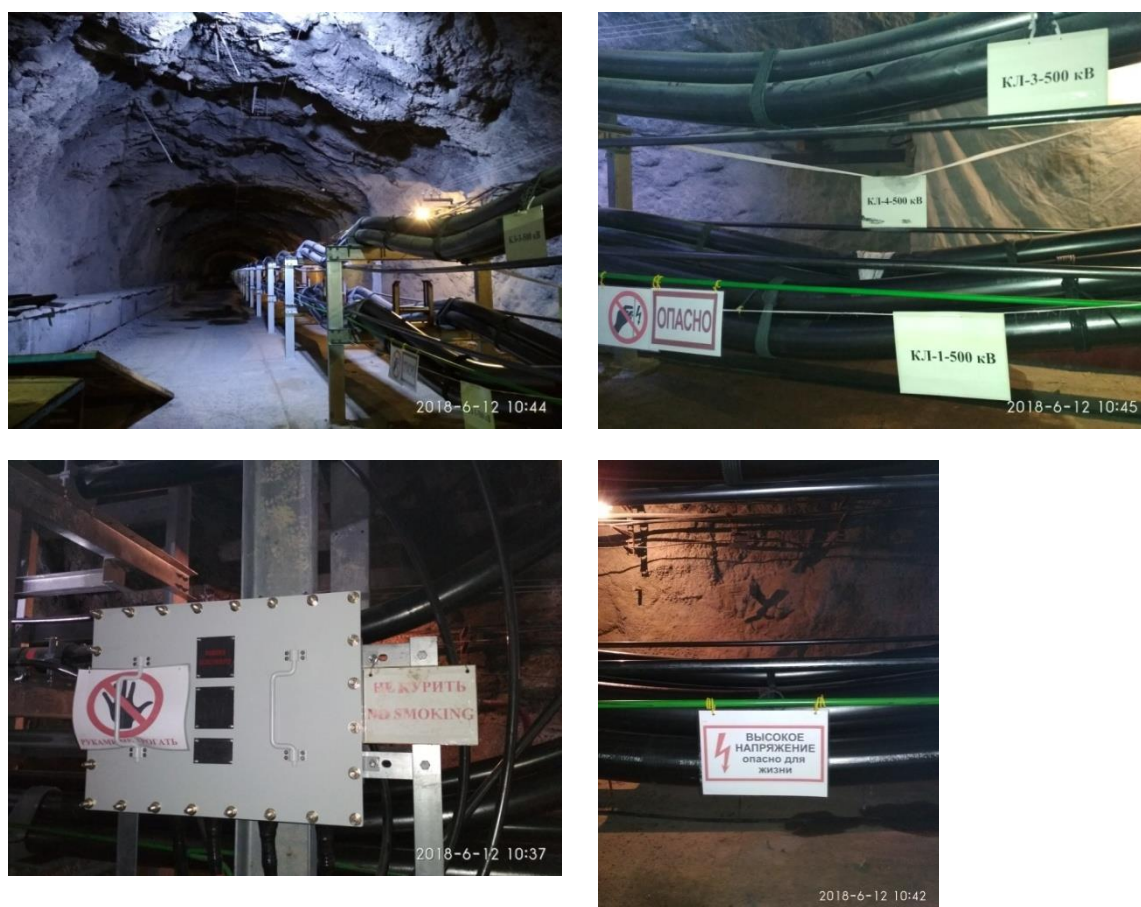
71. In the tunnel, the work continues. The grounding installation is under implementation. The Korean contractor was reminded to fasten pointers or lighting tape at the metallic crossbar near the Top Point. But all required warning signs were placed in the cable tunnel (Picture 29).

Picture 29. Warning signs placed in cable tunnel (Status in June 2018).

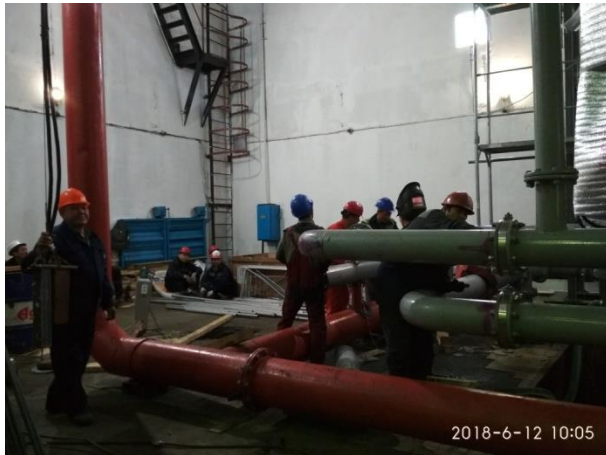
72. In the turbine shop. When installing a transformer, couple of workers at a scaffolding and on the top of the transformer did not fasten their safety belts. A few of them even worked without

helmets and protective gloves. But it should be noted that all workers are equipped with PPE and wear PPE during works at HPP and strictly follow H&S rules and regulations (Picture 30, 31).

Picture 30. Workers at transformer installation wearing proper PPE (Status in June 2018)

83. Both the Chinese and Korean contractors received notes on personal protective equipment as a few workers forgot to wear PPE like helmets. The contractors' HSE specialists were informed about this fact and requested to take immediate measures and will control it on a daily basis.

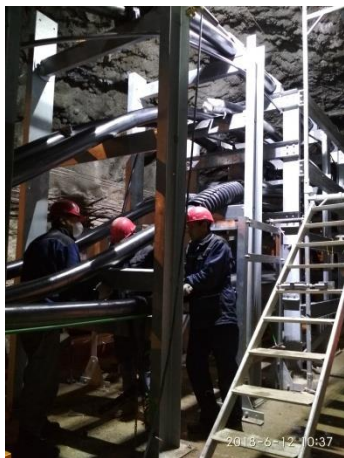
Picture 31. Workers at cable tunnel wearing proper PPE (Status in June 2018)

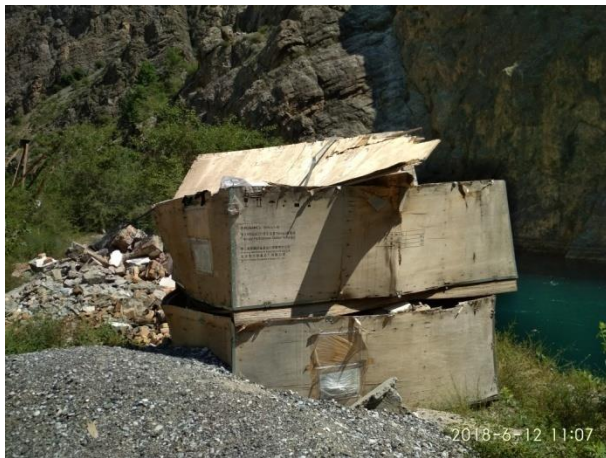
75. Construction waste is a main issue regarding waste management. Construction waste is accumulated (Picture 33), and then it is transported to the site designated for this purpose – to warehouse No3. Construction waste is reused as much as possible at Toktogul HPP. Construction waste will be removed from warehouse No3 to appropriate landfill as there is accumulated enough volume of it. Household garbage is taken out once a week according to the existing last year agreement between Korean contractor and the Cascade of Toktogul HPP responsible for the garbage removal.

Picture 33. Construction waste temporarily placed at the site (Status in June 2018).

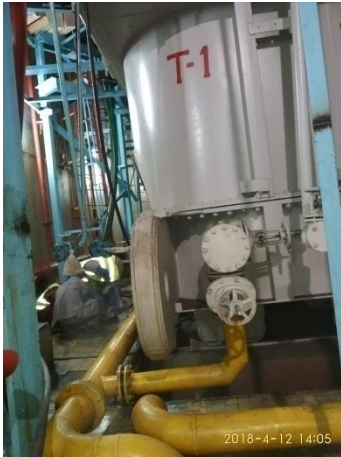
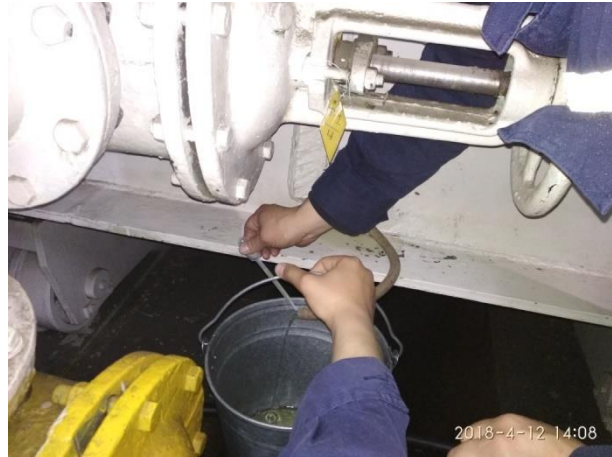
78. During sampling the cable and transformer oil, the Cascade of Toktogul HPP Chemical laboratory personnel jointly with Ms Jyldyz Moldosanova took 7 samples from different points and equipment: one sample from Unit 1 main transformer (Picture 34); one sample from auxiliaries

Picture 34. Oil sampling from Unit 1 main transformer of Toktogul HPP (Status in April 2018)

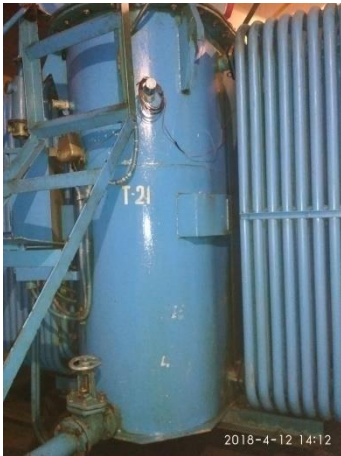
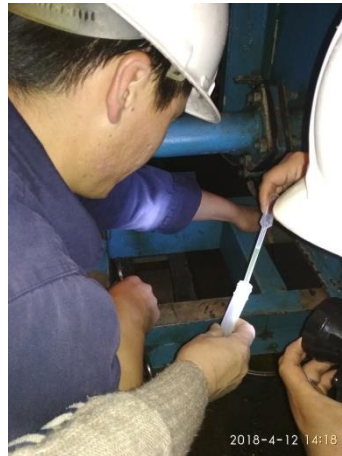
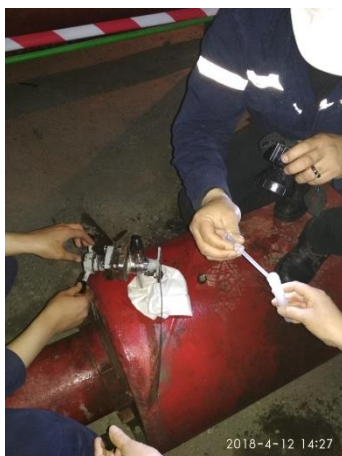
transformer 21 (Picture 35) and five samples from Unit 1 cable line 500kV(Picture 36). Oil testing for PCB was made by L2000DX Analyzer (Picture 38, 39).

Picture 35. Oil sampling from auxiliaries' transformer 21 of Toktogul HPP (Status in April 2018)

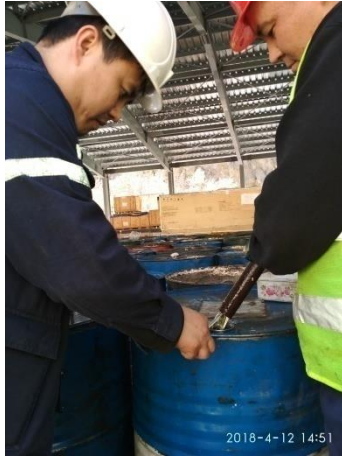
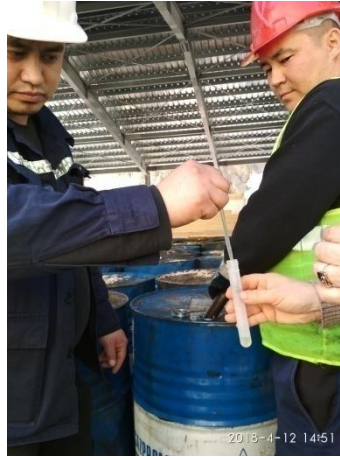
Picture 36. Oil sampling from Unit 1 Cable Line 500 kV of Toktogul HPP (Status in April 2018).

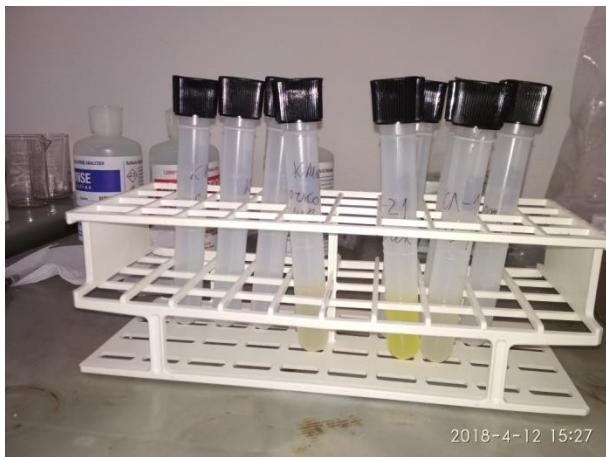
79. Oil samples were analyzed at the same day by L2000DX Analyzer at Chemical Laboratory of the Cascade of Toktogul HPP (Picture 37).

Picture 37. Cable and transformer oil samples ready for test by L2000 Analyzer DX (Status in April 2018).

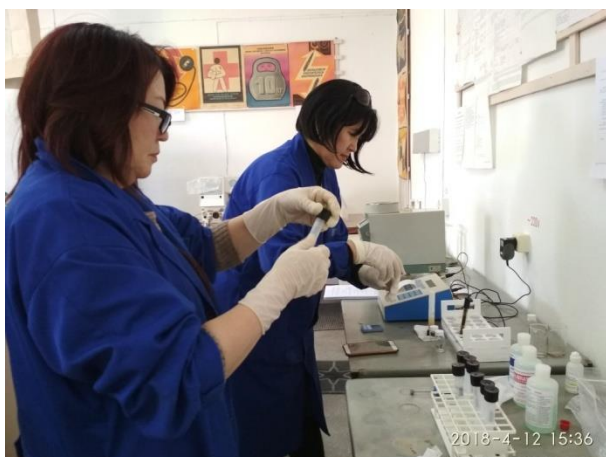
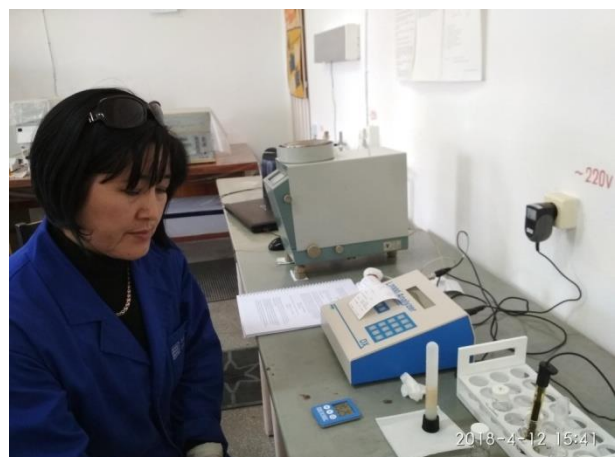
80. All 7 samples were analyzed for PCB by the Chemical Laboratory of Cascade of Toktogul HPP personnel (Picture 38). Results confirmed the previous analyses made in 2014 presented in IEE set up to the Project (see below Table 5). Automatically generated protocols made by L2000DX Analyzer are shown in Picture 39.

Picture 38. Performing of oil test for PCBs by Toktogul HPP personnel (Status in April 2018).

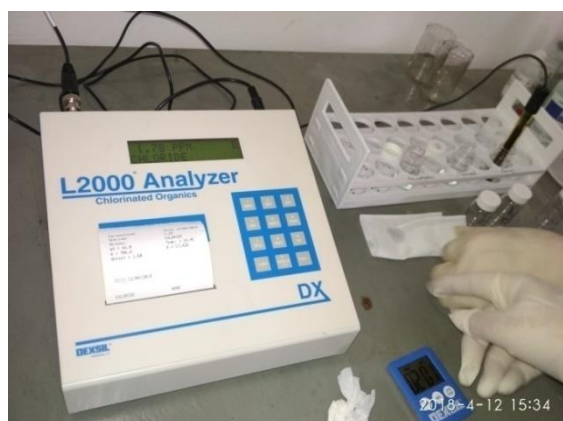
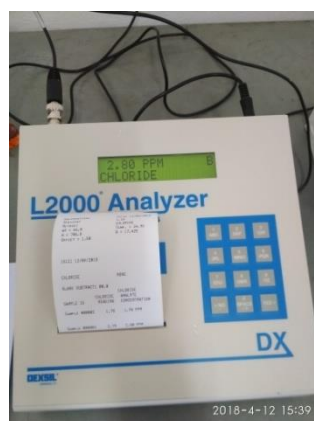
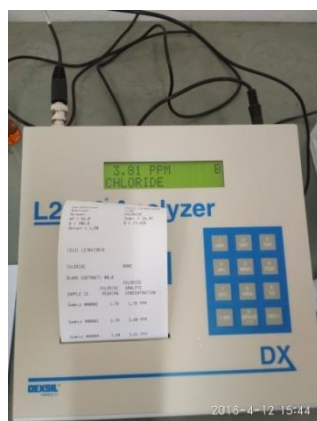
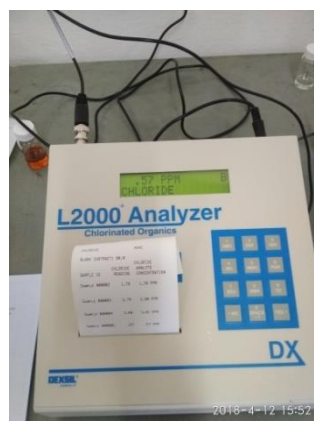
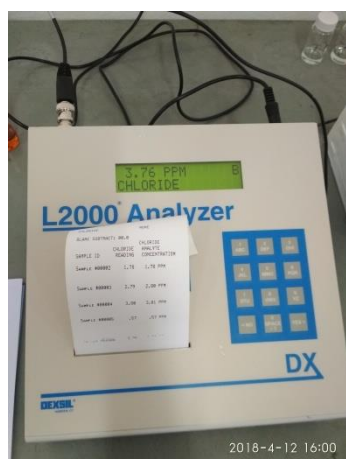
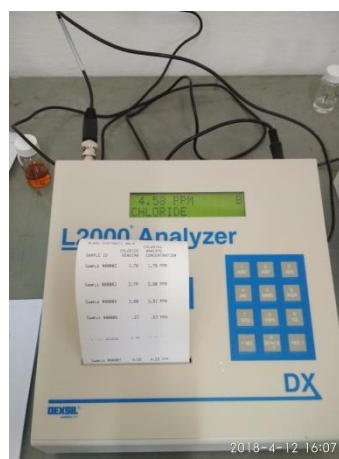
Picture 39. The automatically generated reports of the analyses made by L2000DX (Status in April 2018).

81. The PCB concentrations in all samples were below 50 µg/kg. Thus, these oils can be considered to be free of PCB and no specific measures in handling or disposing them are needed. The consolidated automatically generated report is attached in Annex 5.

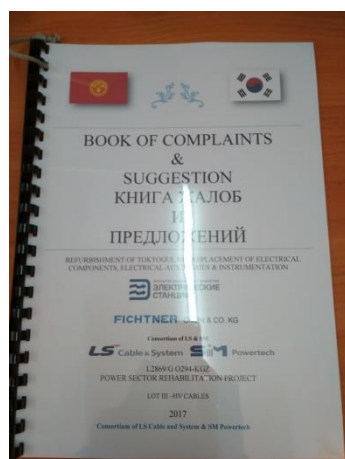
88. Both Korean and Chinese Construction Contractors have GRM Log Books at sites (Picture 40). There have been no complaints raised so far, neither by workers nor by the population. GRM log books are filled up appropriately.

Picture 40. Compliance Books in the field offices of the Construction Contractors and are easily accessible.
