Environmental Monitoring Report

Semi-annual report
January - June 2023

Kyrgyz Republic: Toktogul Rehabilitation Phase 2 Project

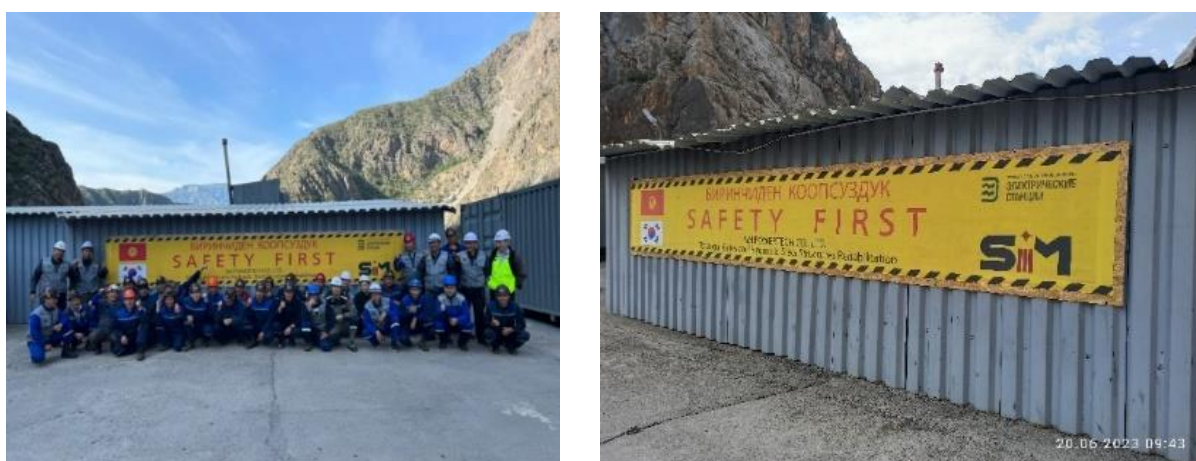
Figure 3. Work staff of CC ZMEC after briefing with Safety poster in work area (Status in June 2023)

53. Appropriate informative signs were placed at work areas. It should be noted the informative signs related to HSE issues at site of the contractor ZMEC are enough and very informative (Figure 4). Work staff is fully equipped with PPE (Figure 3). Construction and installation works were carried out in compliance with HSE requirements.

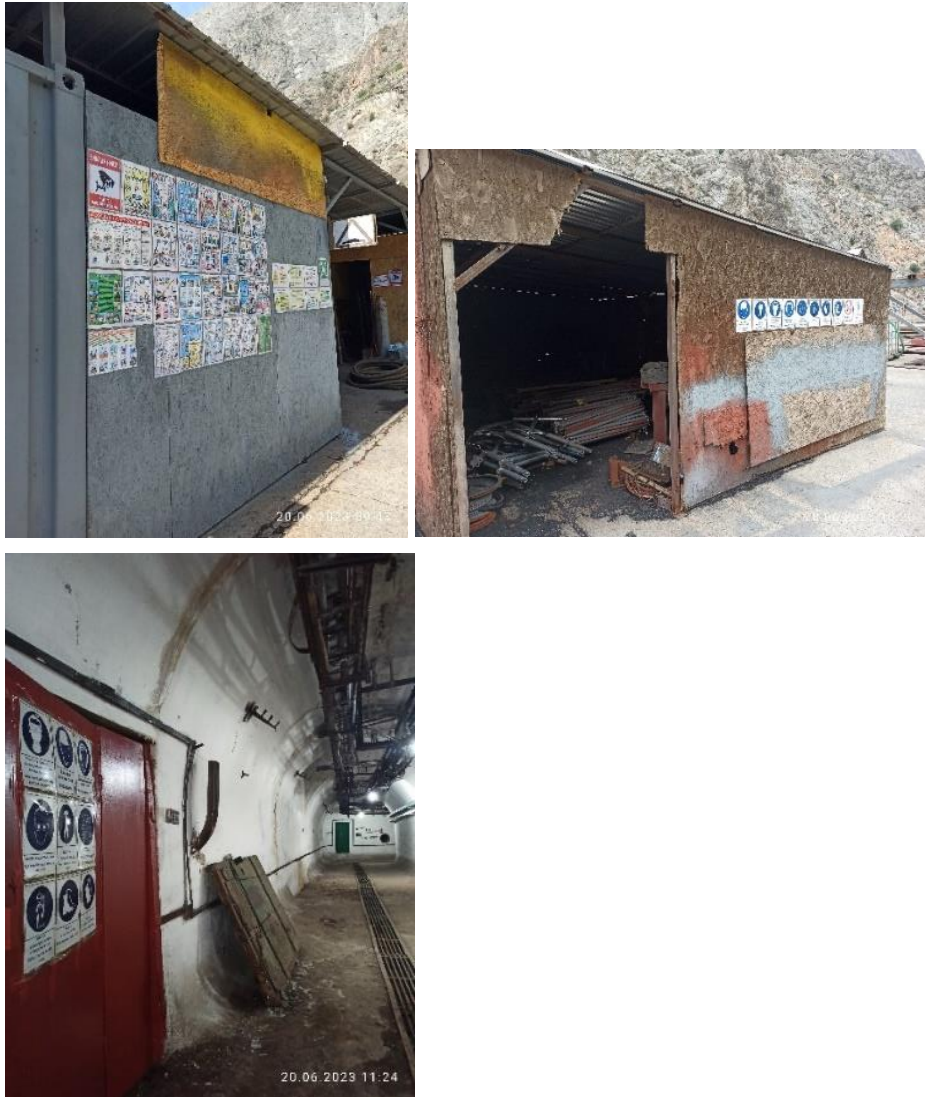
Figure 4. HSE informative signs are placed in all work areas of CC ZMEC (Status in June 2023)

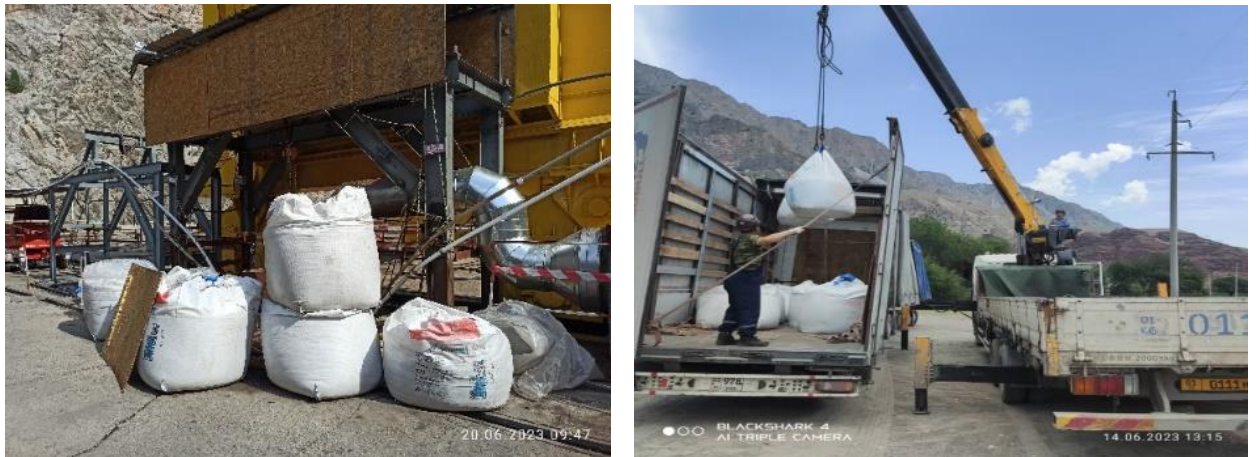
54. Construction waste was transported to the designated storage area No.3 of Cascade of Toktogul HPP. Domestic waste was removed to official landfill according to an agreement. The used abrasive was packed in special bags and placed in a designated place by the Customer on the dam crest and further removed to the certified landfill in accordance with agreement (Figure 5).

Figure 5. Removing of abrasive waste from site of CC ZMEC (Status in June 2023)

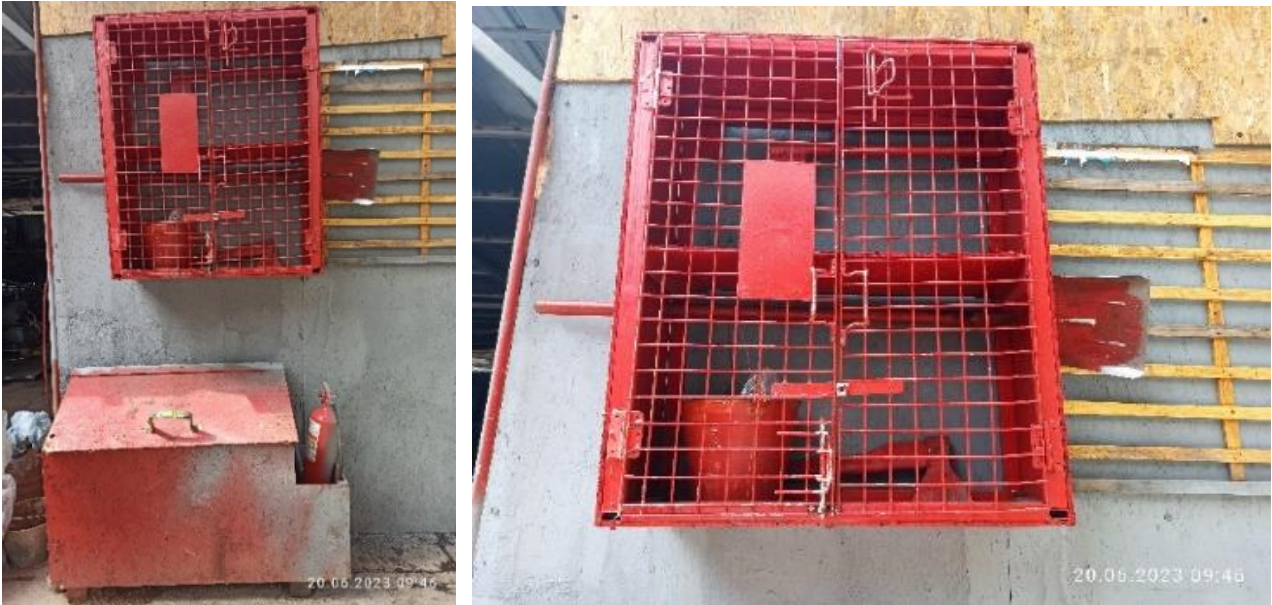
55. Chemicals/painting were stored with secondary protection at site (Figure 6). Access to firefighting equipment was easily available to the workers working in the area (Figure 7). Portable toilets are available for workers working in the area (Figure 8).

Figure 7. Firefighting equipment of CC ZMEC at site (Status in June 2023)

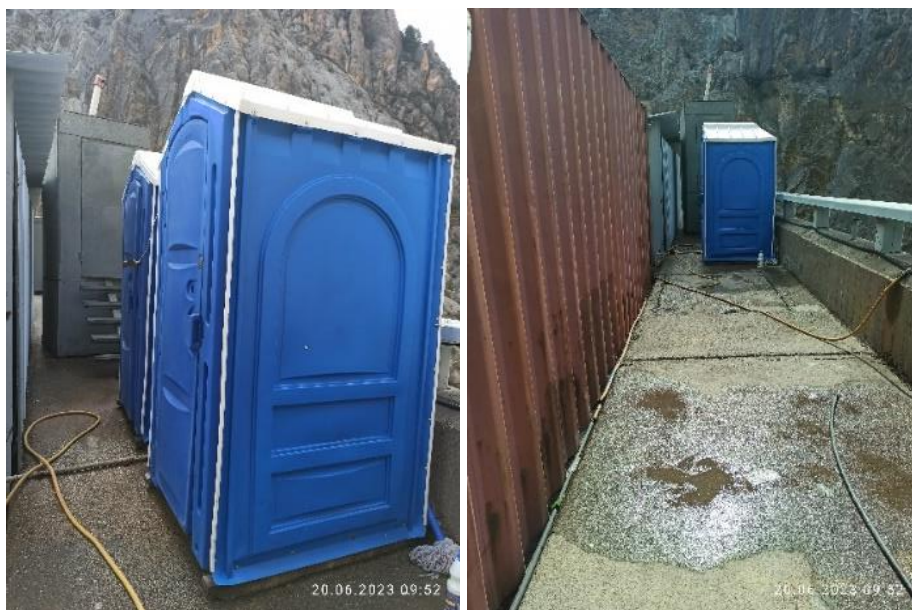
Figure 8. Portable toilets are available for workers working in the area of CC ZMEC (Status in June 2023)

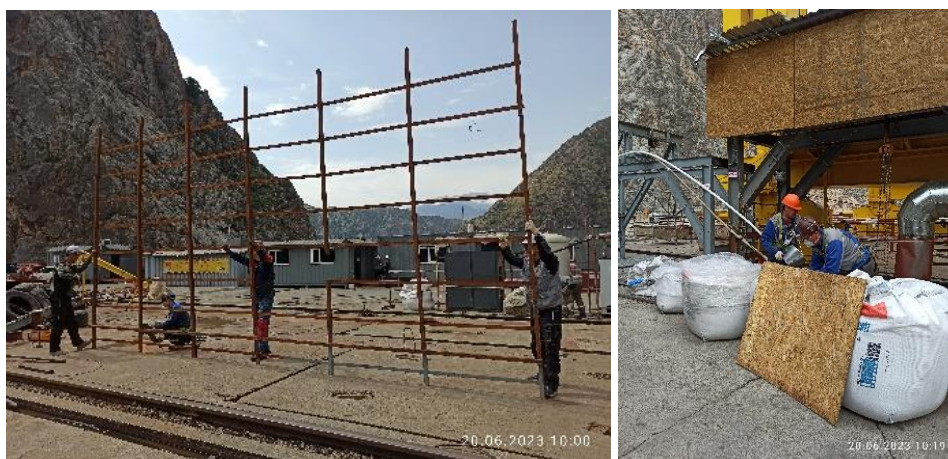
56. Workers are fully equipped with appropriate PPE (Figure 9).

Figure 9. Work staff of CC ZMEC implementing works wearing PPE (Status in June 2023)

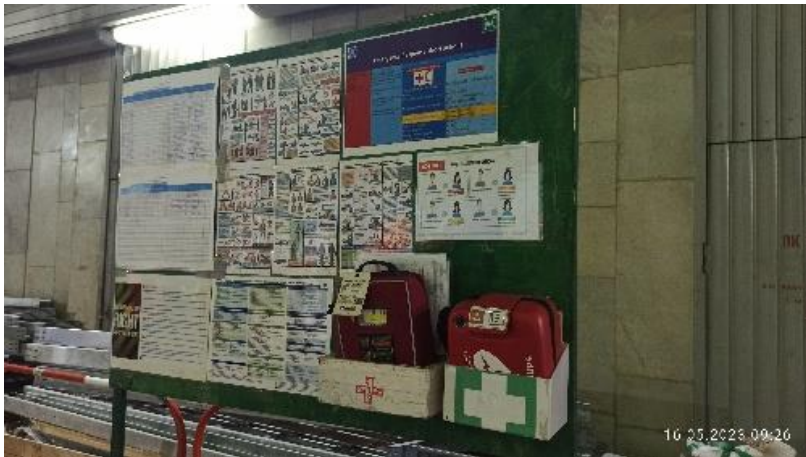
59. First aid kits are available for workers of CC GE working at project areas (Figure 10).

Figure 10. First aid kits are available for workers of CC GE at site (Status in May 2023)

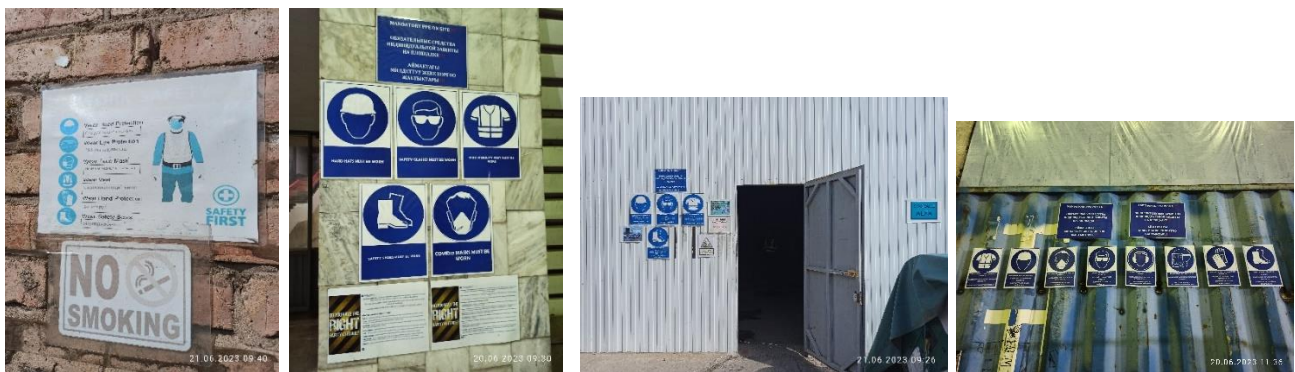
60. HSE informative signs were placed in all project areas of CC GE.

Figure 11. HSE informative signs of CC GE at site areas (Status in June 2023)

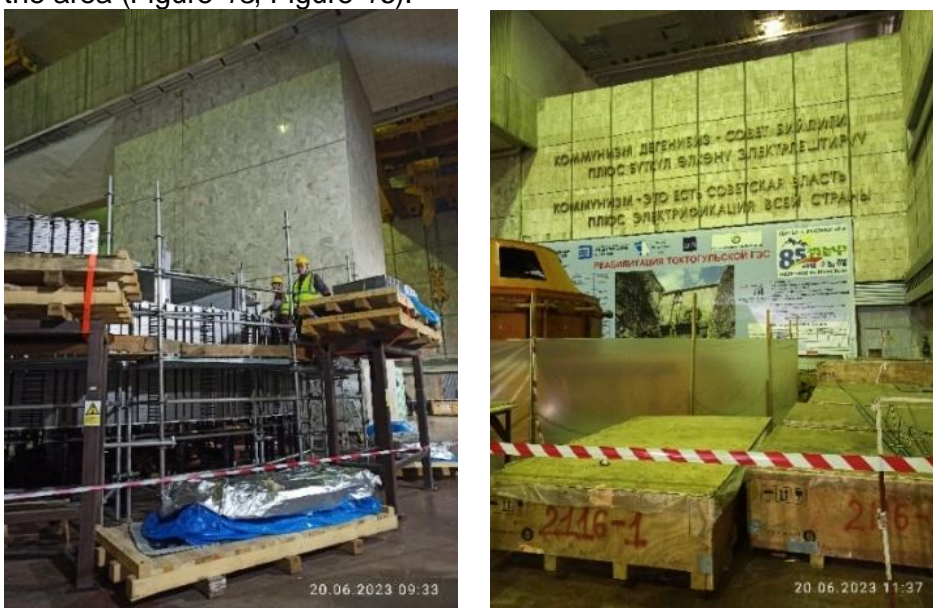
61. Work areas of CC GE in machine hall of Toktogul HPP was fenced (Figure 12). Working personnel worked with full PPE. Emergency eye wash stations are available to the workers working in the area (Figure 13, Figure 16).

Figure 12. Fenced work areas of CC GE in machine hall of Toktogul HPP (Status in June 2023)

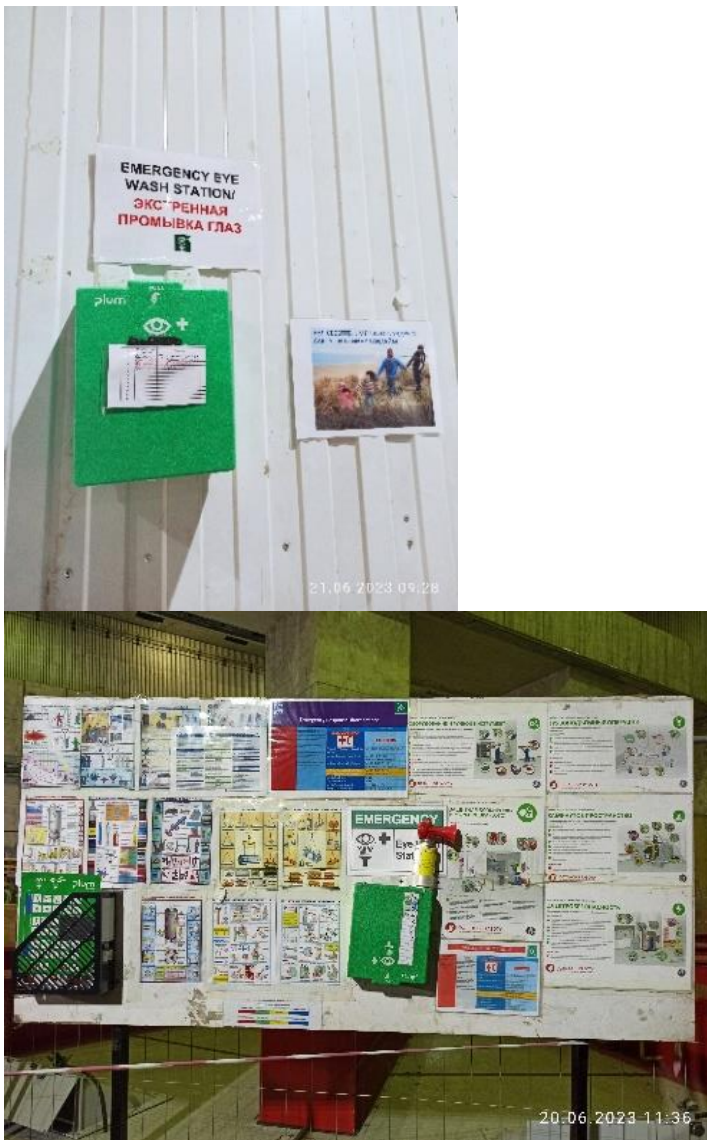
Figure 13. Emergency eye wash stations are available to the workers of CC GE at site (Status in June 2023)

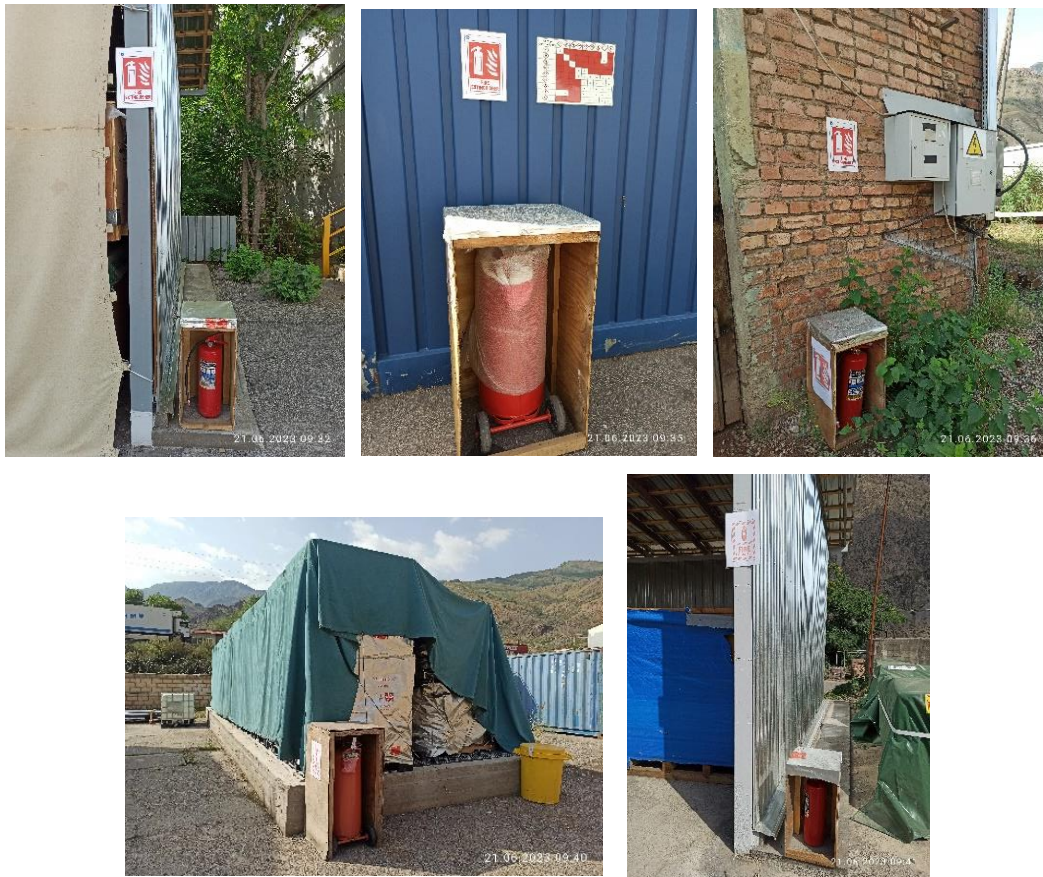
62. Dedicated fire extinguishers have been installed. Argon cylinders, empty cylinders have been properly stored with informative boards (Figure 14, Figure 15).

Figure 14. Fire extinguishers installed at CC GE storage site (Status in June 2023)

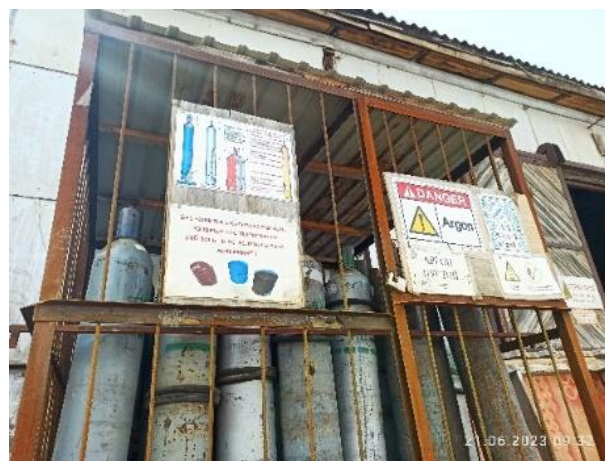
Figure 15. Storage of empty cylinders of CC GE at site (Status in June 2023)

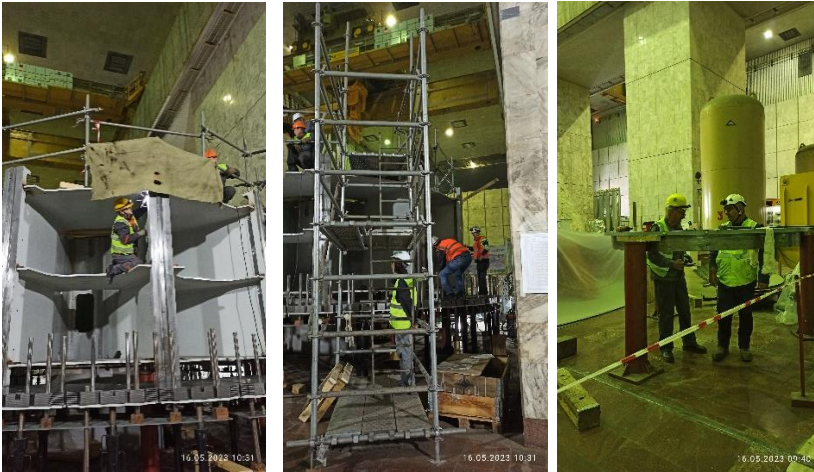
63. Work staff of CC GE is fully equipped with PPE (Figure 16).

Figure 16. Work staff of CC GE working in compliance with HSE requirements, wearing PPE (Status in May 2023)

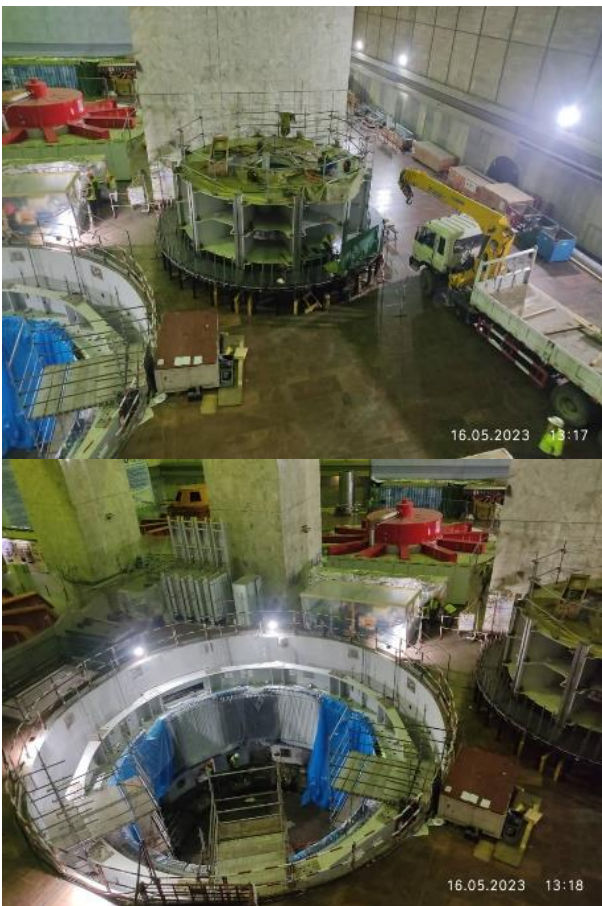
58. Rehabilitation work is carried out strictly on the allotted area of the Toktogul HPP in machine hall and storage areas which are fenced and has paramilitary guard. Construction works were conducting in compliance with health and safety measures by CC GE and its sub-contractors (Figure 17). Appropriate PPEs were provided to work staff. No accident was occurred during reporting period. Meetings with HSE specialists of CC GE were held with discussion of health, safety and environment measures implementation at the field office of CC GE.

Figure 17. Work area of CC GE in machine hall of Toktogul HPP (Status in May 2023)

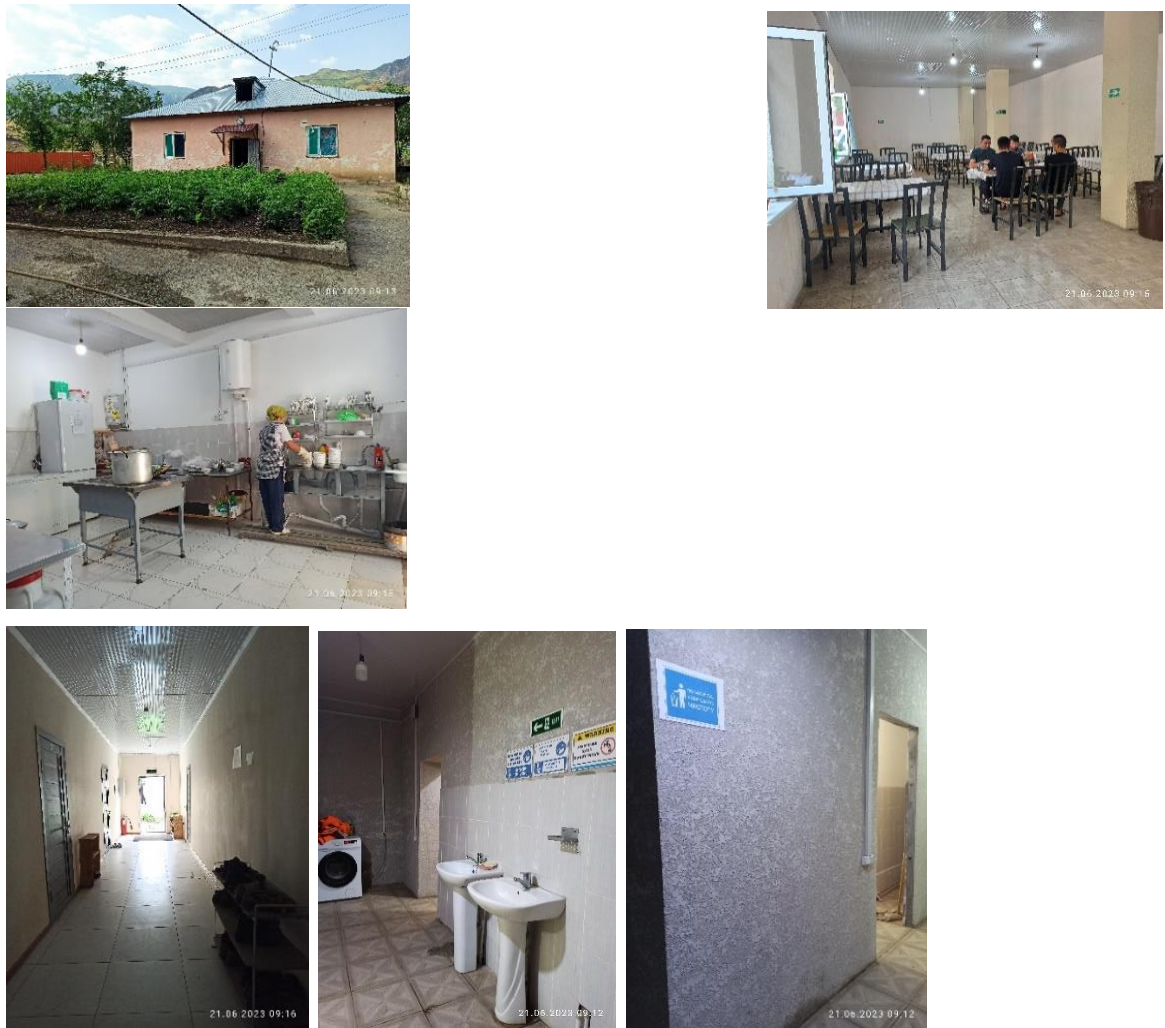
69. Accommodation place of TajikSGEM personnel, a contractor of CC GE was checked as well. TajikSGEM personnel lives in a dedicated accommodation place. Two old buildings on the Toktogul HPP storage territory have been refurbished with the canteen. The camp has all the conditions for living (Figure 23).

Figure 23. Camp of the TajikSGEM, a contractor of CC GE (Status in June 2023)

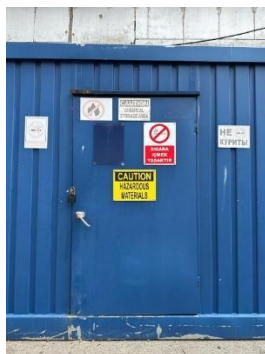
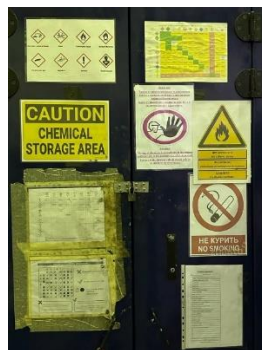
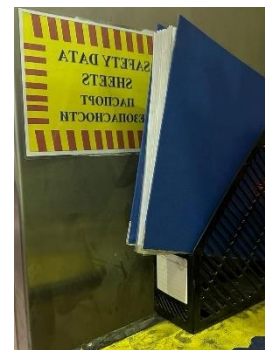
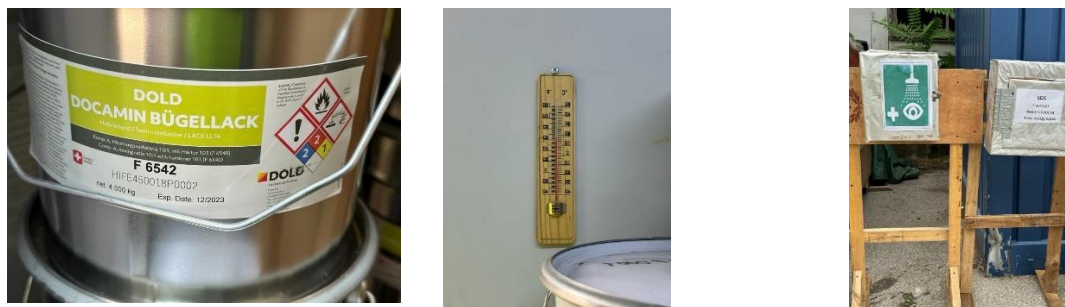
Figure 27. Chemical storage area of CC GE at site (Status in February 2023)

- Chemical management: the chemical register shows the different hazards of each chemical.
- The dashboards at the chemical's storages display the storage compatibility matrix.
- Chemicals are stored in closed cabinets on retentions with inventory lists and SDSs for each chemical.
- All oil storages at site has secondary containment.

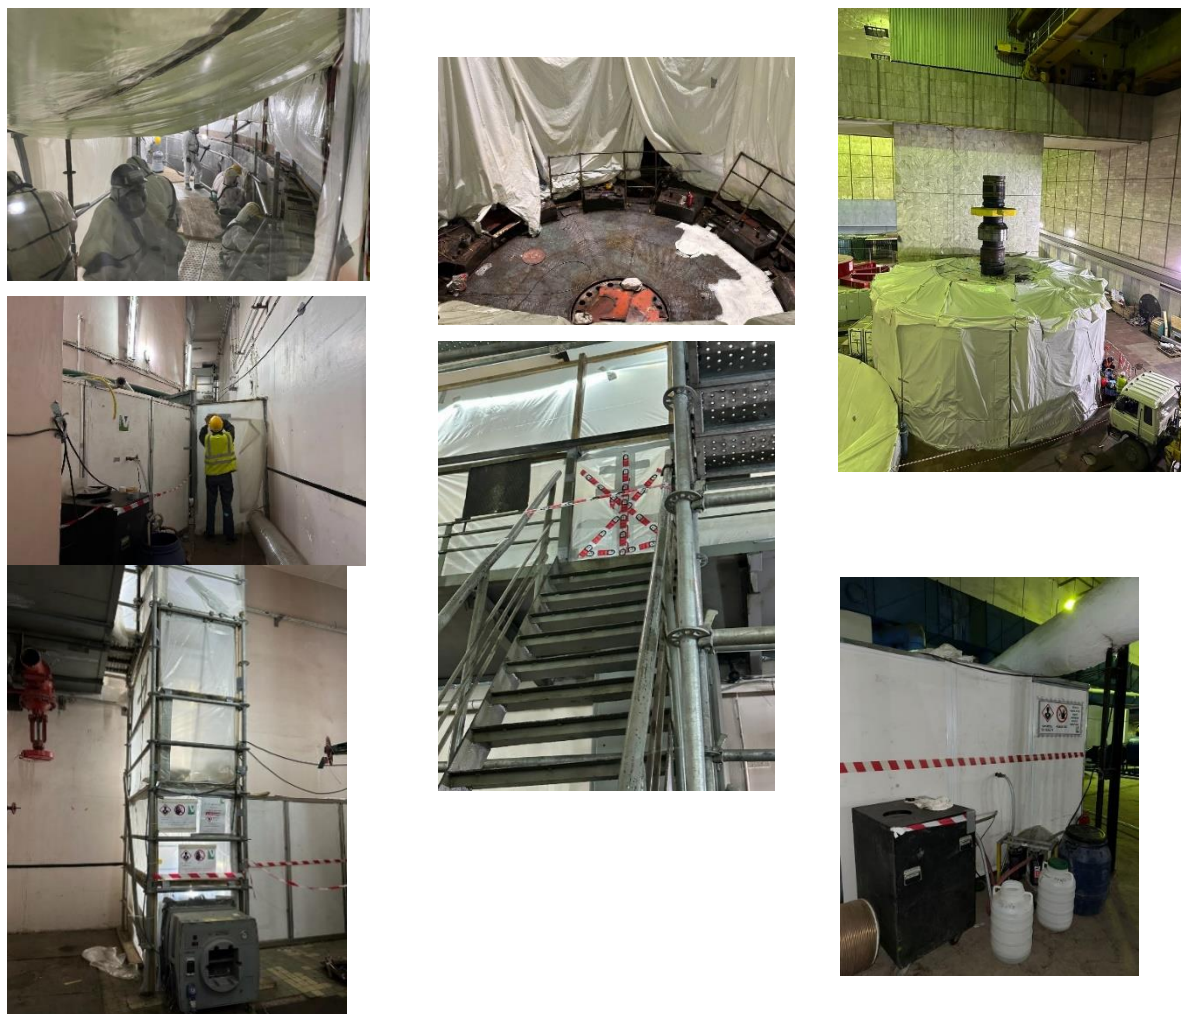
- Asbestos cleaning of the generator pit;
 - Asbestos cleaning of the Unit 2 cables including the cable trenches and shafts.
109. Work method as was described in the ACMMP was followed-up. Containment (encapsulation) of the work area entirely by plastic sheets was necessary so that the asbestos fibers in the air were contained (Figure 29). The workforce used full asbestos PPE and other protection measures. Vermeulen provided training only for their personnel.

Figure 29. Confinement / isolation of existing asbestos areas and organization of work area of CC GE (Status in April 2023).

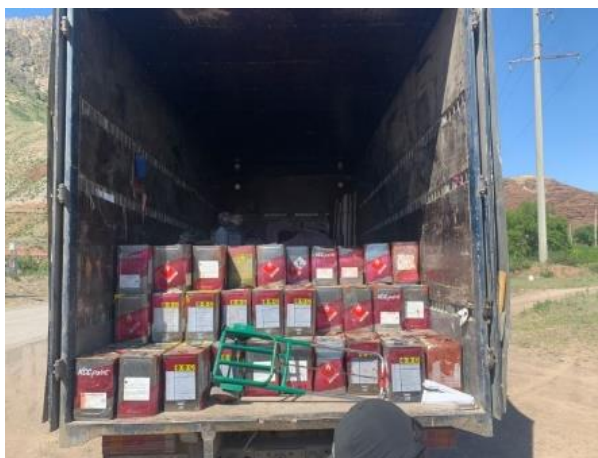
Figure 30. The empty paint cans of CC ZMEC were transferred for disposal (Status in May 2023)

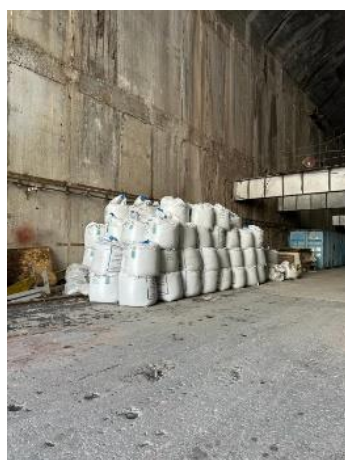
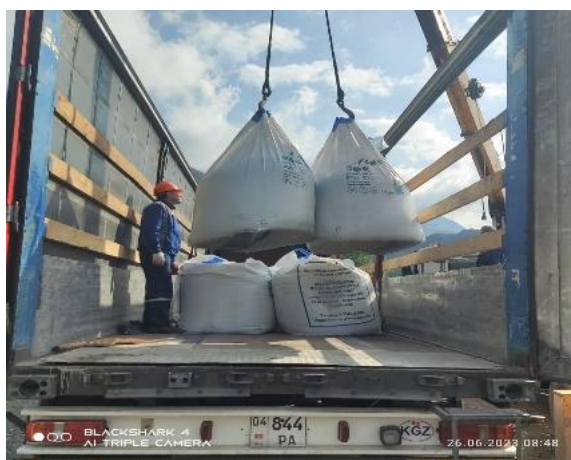
- Scrap metal is handed over to Cascade of Toktogul HPPs after complete dismantling of the gantry crane equipment;
- Non-toxic construction waste is placed in a warehouse specially designated by the Cascade of Toktogul HPPs (Base N3) for further sorting for reuse;
- Disposed amount of empty painting cans were 1849 kg. Empty paint cans were removed on 11 May 2023 in accordance with an Agreement between CC SMP&ZMEC and specialized licensed local company “Eco Complex” (Figure 30) (Annex 3).
- Domestic waste was removed from the site and disposed of in accordance with agreement between SM Powertech and Cascade of Toktogul HPP for the removal of solid waste.
- Abrasive waste - after full use was disposed of in a landfill according to the agreement. During the reporting period, CC ZMEC disposed abrasive waste **in the amount of 192 tons** (Figure 31).

Figure 31. Temporary storage of abrasive waste at site of CC ZMEC and transportation for disposal (status in May-June 2023).

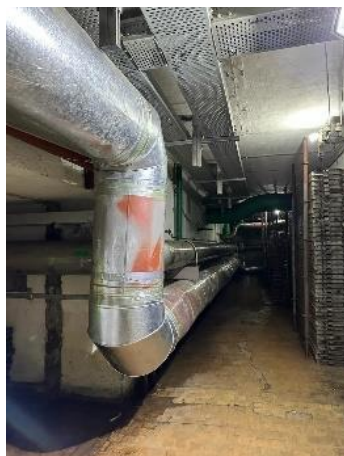
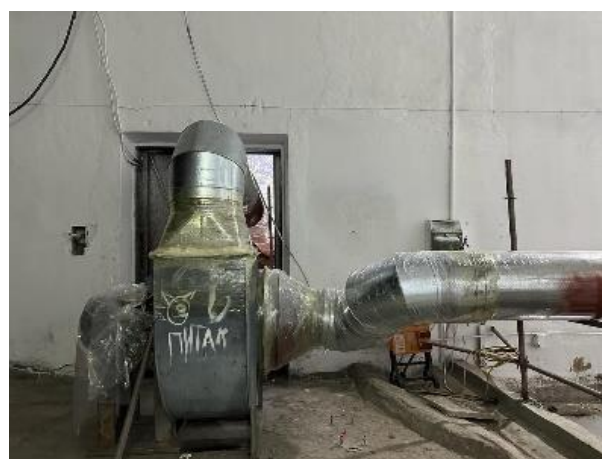
122. A short-term effect on the atmospheric air is generated by the contractor's transport and lifting equipment (crane truck and manipulator), which is used to move people and during the delivery, unloading and assembly of equipment at the construction site. The engines work for a short time, at the time of movement and construction work.
123. To reduce of air pollution during the sandblasting works CC ZMEC installed additional ventilation system from penstock on elevation 707 m to the draft tube stop log maintenance gate room on elevation 732 m.

Figure 33. Additional ventilation system of CC ZMEC (Status in June 2023)

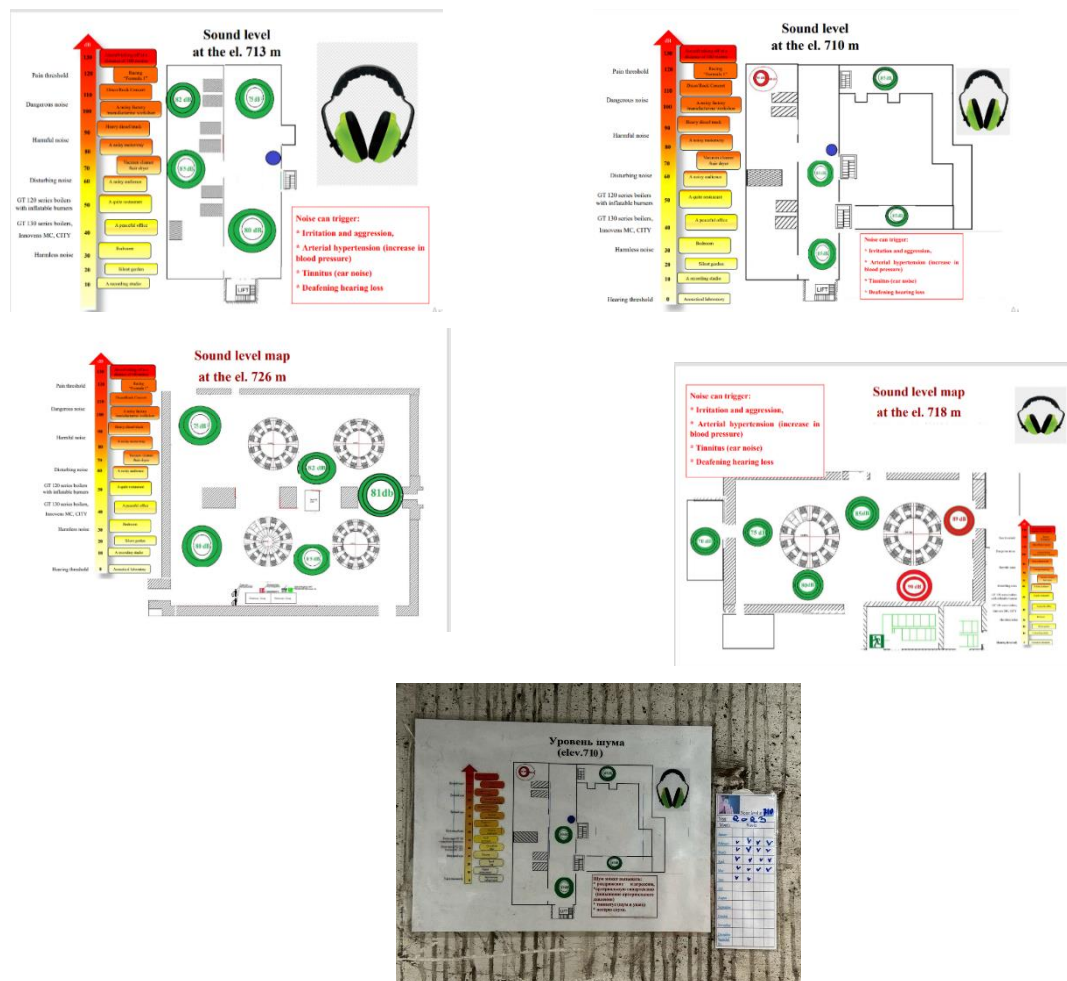
124. During welding to prevent metal fumes and odor, air suction fans are in use by CC GE.
125. For sandblasting activities, specific respiratory system and ear plugs are used by the personnel, sandblasting equipment was selected according to international standards and local regulations regarding the noise level.
126. CC GE has a noise map for each elevation (Figure 34). They have inspection sheet on place; they measure level of noise every week.

Figure 34. CC GE's noise maps for each elevation (Status in May 2023)

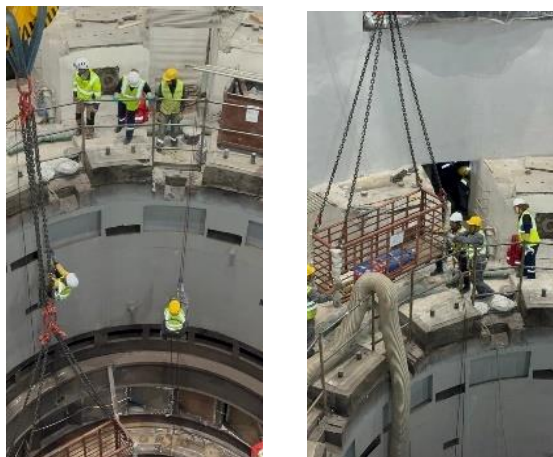
143. One week of June 2023 was declared the EHS week. CC GE HSE team conducted daily toolbox talks for employees on the different EHS topics.
144. No chemical spill has been reported.
145. Spill kits were present at site.
146. To prevent the fire risk, fire blankets and fire extinguishers were in place during welding activities conducted for crane refurbishment. In addition, all welding machines are periodically inspected and calibrated.
147. The emergency response plan was explained during EHS inductions. Last update of the emergency response plan during the reporting period was in January 2023. Updates of escape routes were incorporated.
148. There are 3 muster points and one alternative in case of flood.
149. During reporting period, CC GE conducted 5 Emergency drills (Figure 38).

Figure 38. Emergency drill of CC GE (status in May 2023)

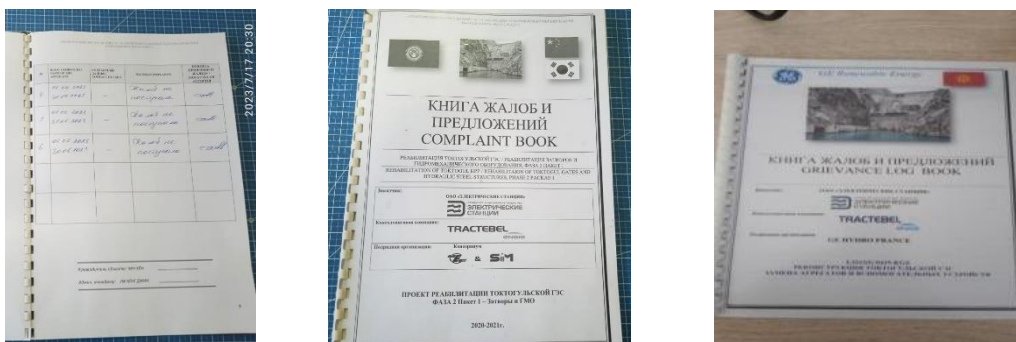
153. From information transmitted by CC GE and CC ZMEC in their reports (including check at site for ZMEC), no complaint has been raised during reporting period, neither by workers nor by the population. GRM log books were filed up appropriately (Figure 39).

Figure 39. Compliance Books in the field offices of the Construction Contractors are easily accessible

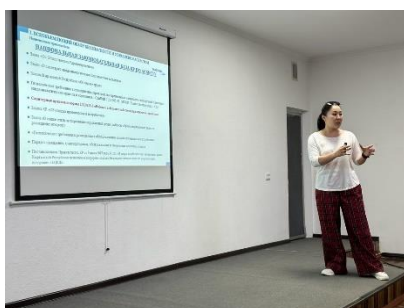
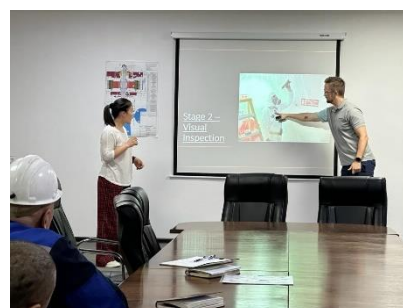
156. During the reporting period, Asbestos awareness training was conducted by PIC Tractebel and CC GE’s supervisor of asbestos works Anthesis for Toktogul HPP staff on 26 of June, 2023. This training included general international and national law frameworks, health and safety requirements for asbestos handling, storage and disposal, and asbestos related diseases (Figure 40).

Figure 40. Training on asbestos awareness for Toktogul HPP staff (Status in June 2023)

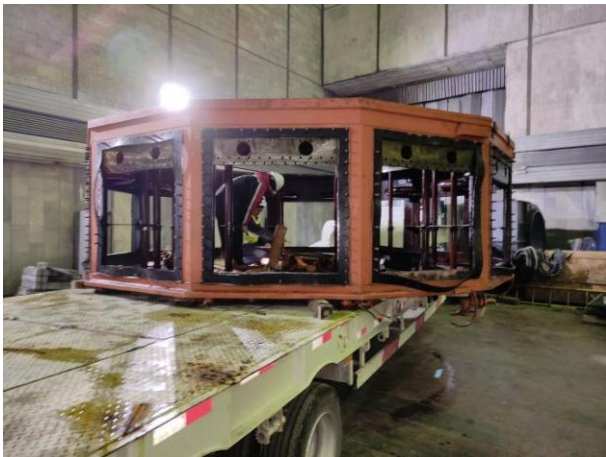
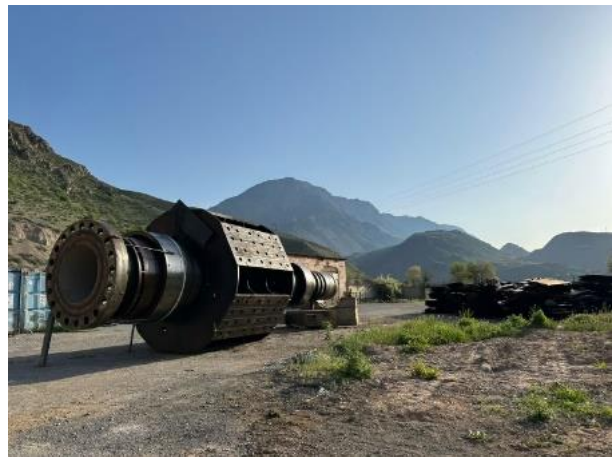
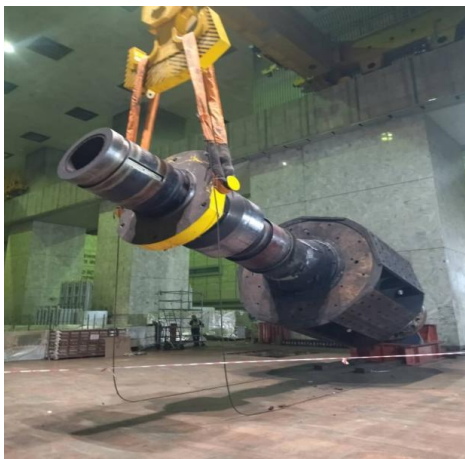
Figure 41. Relocation of disassembled equipment from Unit 2 to the Employer's storage (Status in April 2023).

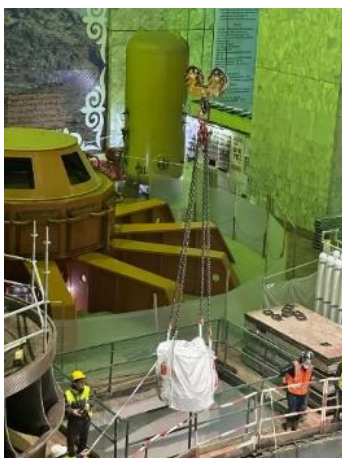
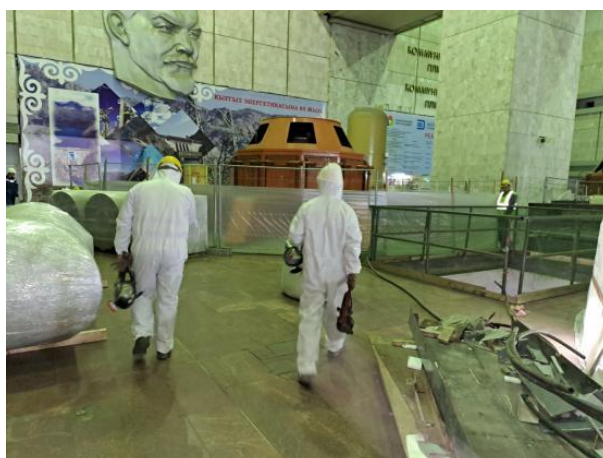
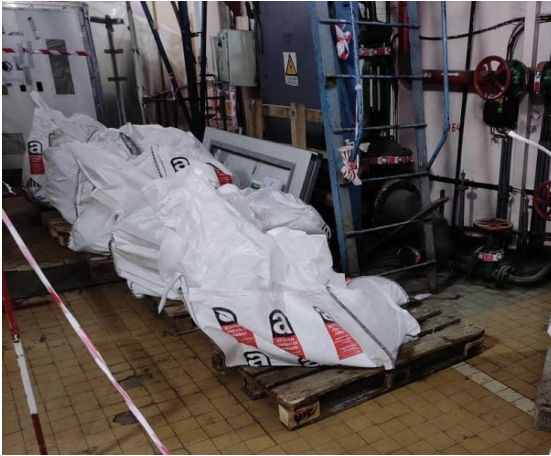
Figure 42. Removal of asbestos-containing debris and asbestos clearance work (Status in March, April 2023).

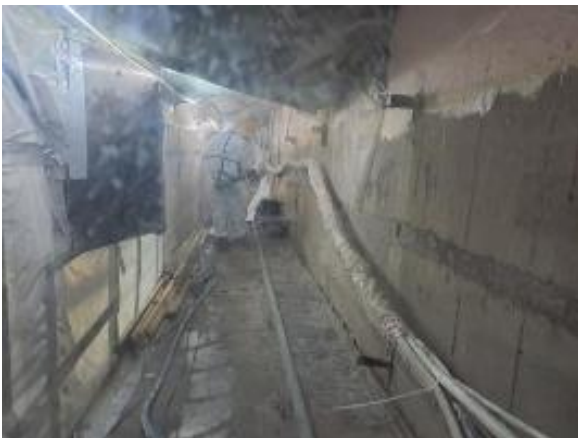
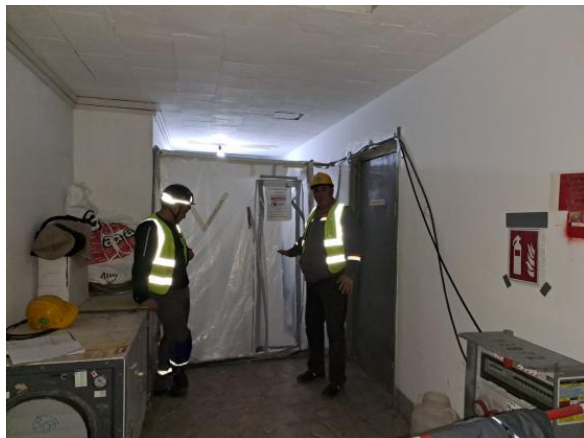
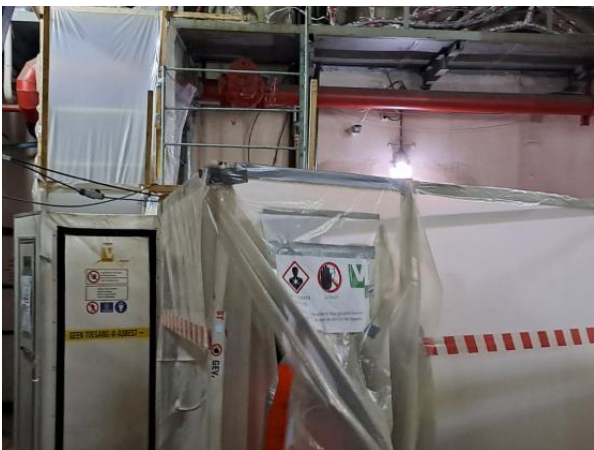
Figure 43. Asbestos cleaning the ventilation system cable gallery (Status in April 2023)

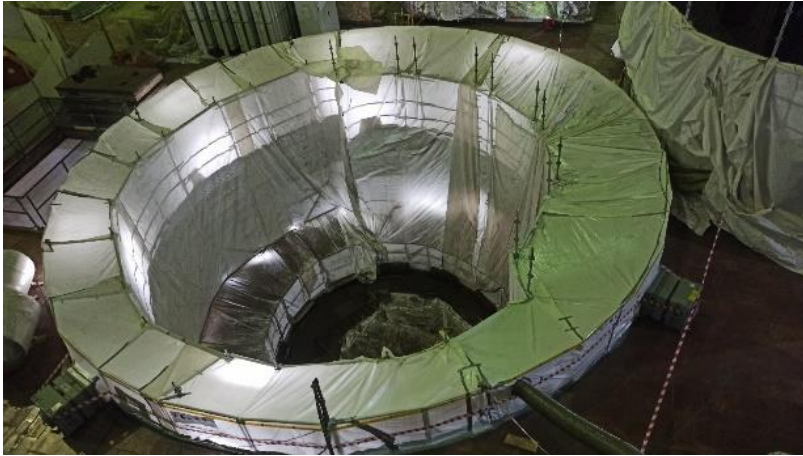
Figure 44. High pressure steam cleaning of the generator pit (Status in April 2023).

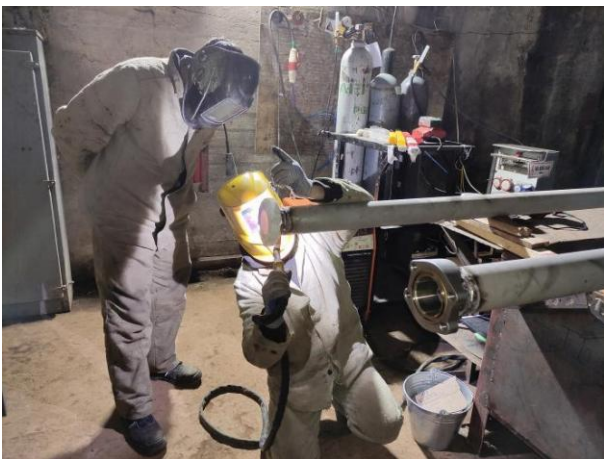
Figure 45. Welding works of the pipe line flanges at the level of 740m (Status in April 2023)

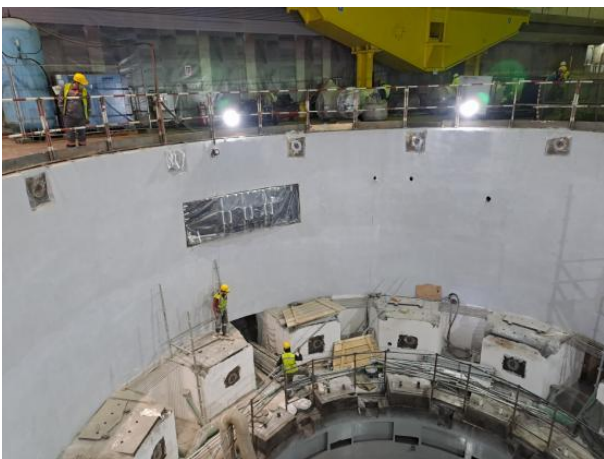
Figure 46. Dismantling scaffolding inside the generator shaft (Status in May 2023)

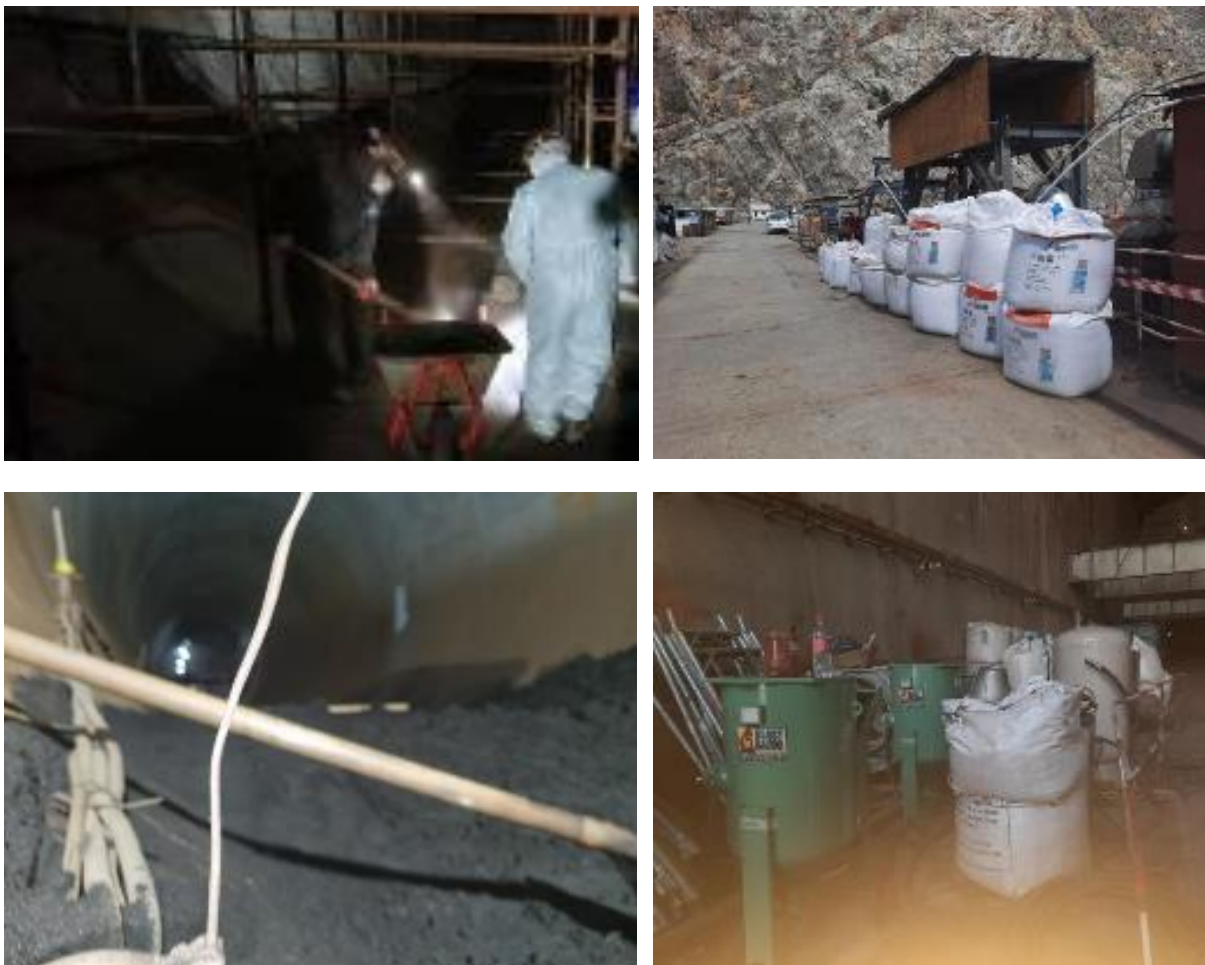
Figure 47. Sandblasting treatment of penstock of Unit 3. Transportation of abrasive debris to the landfill. (Status in May-June 2023).

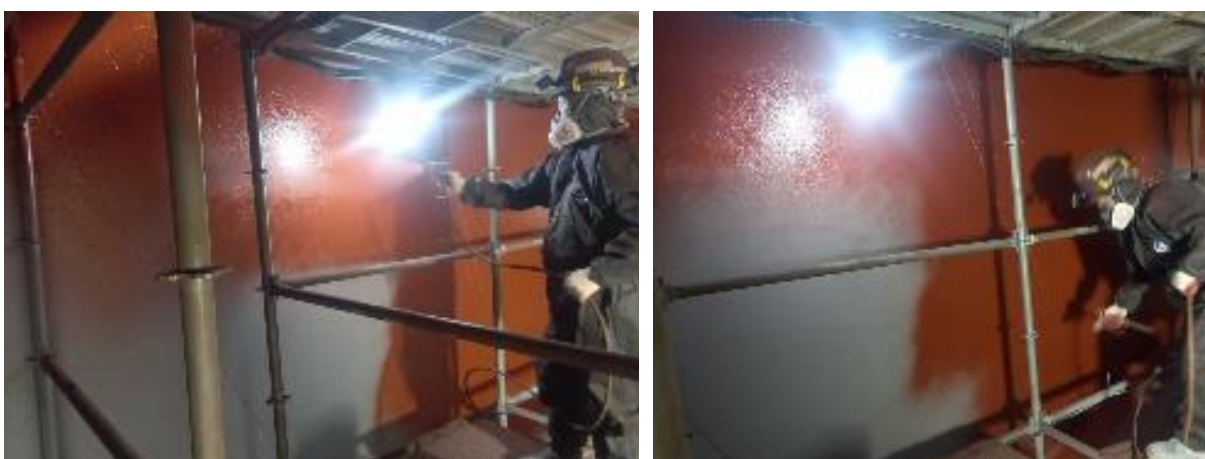
Figure 48. Painting works proceeding of penstock U3 (Status in April 2023)

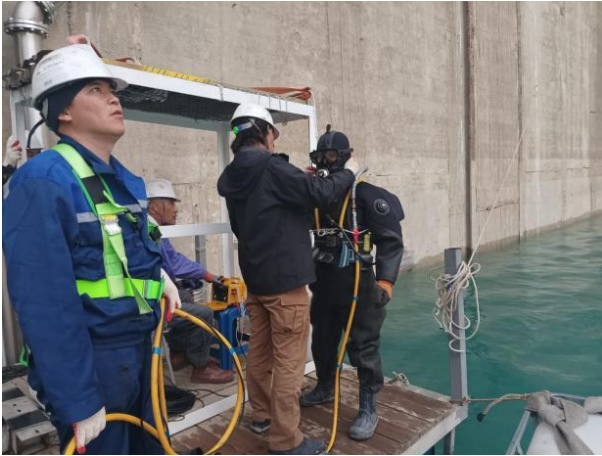
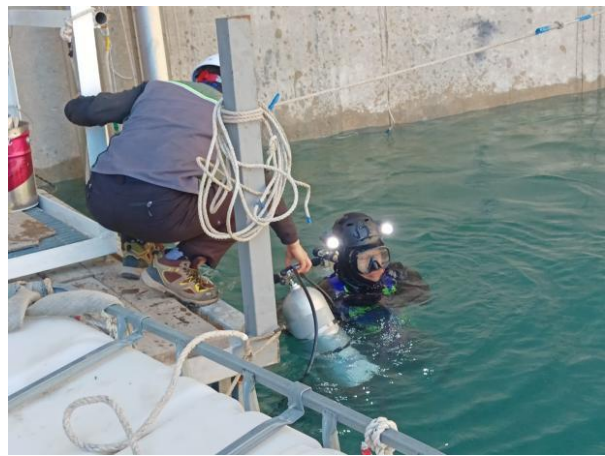
Figure 49. Diving work – installation of aeration pipes of a deep spillway under water (Status in April 2023)

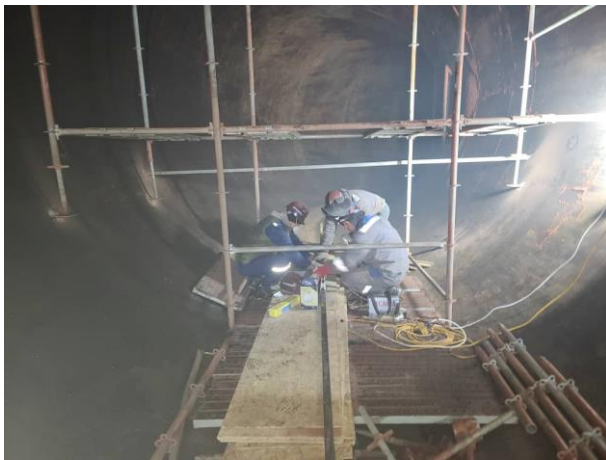
Figure 50. Preparatory work for sandblasting in the Unit 3 conduit (Status in April 2023)
