Environmental Monitoring Report

Semi-annual report
January - June 2023

Kyrgyz Republic: Toktogul Rehabilitation Phase 2 Project

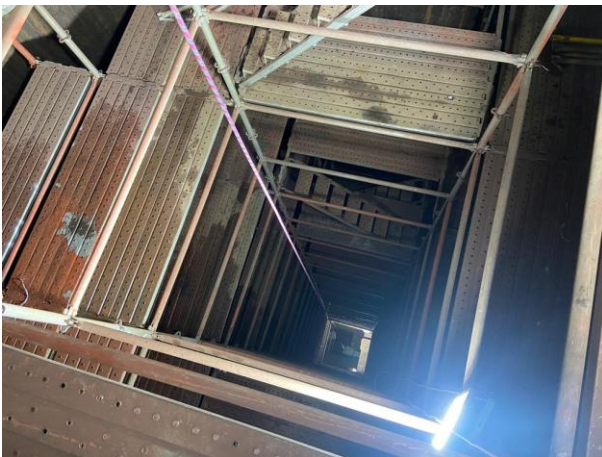
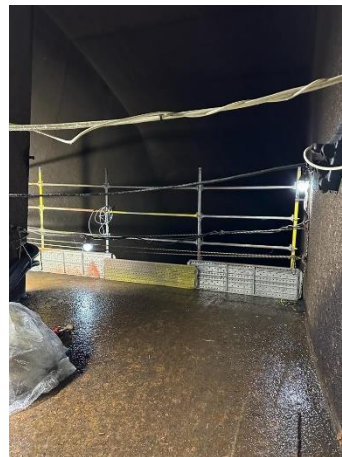
Figure 51. A safety barrier was installed for the construction of scaffolding in the conduit of Unit 3 (Status in May 2023)
